General Information

Make	Mitsubishi	Model	Xpander
YOM	2019	Odo Meter Reading	81,261
Registration No.	NBP1331	Chassis No.	MK2XRNC1WKN002321
CC	1.5	Transmission	A/T
Fuel Type	Gas	Type of Body	Utility Vehicle
Colour	Black

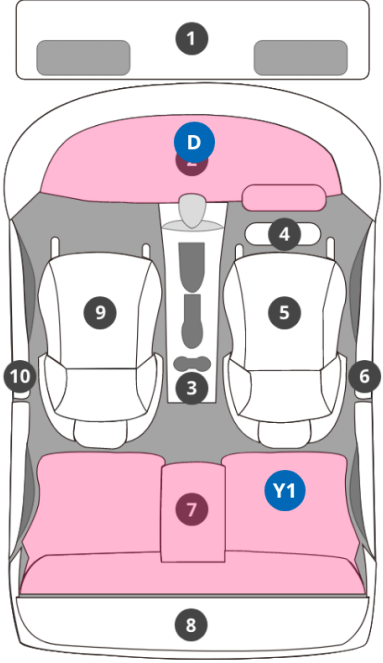
Interior Evaluation : A	Exterior Evaluation : E

<p>a : Cut, Fray d : Loose, Deformed k : Animal Hair s : Smell t : Cigarette Burns x : Defective y : Stain</p>

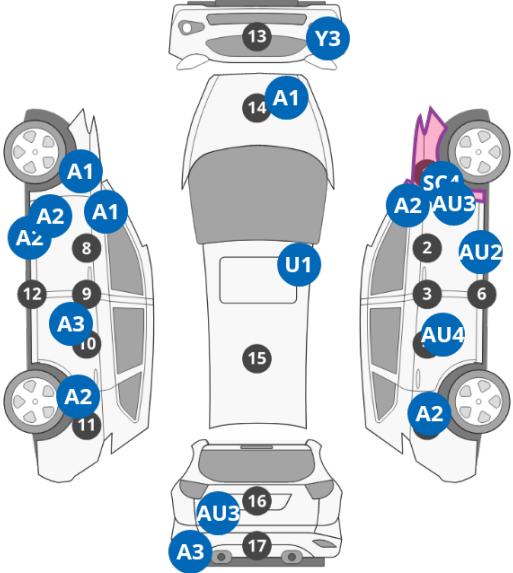
<p>A : Scratch AU : Scratch & Dent B : Modified C : Corrosion G : Stone chip P : Faded S : Rust SC : Rust & Corrosion U : Dent X : Defective Y : Crack, Gap</p>
<p>Remarks Dashboard - Traces of Adhesive Tape - Yes / Rear Seat - Grime - Minimal</p>	<p>Remarks (R) Front Fender - Repair Traces - Yes / (L) Step - Repair Traces - Yes / (R) Front Fender, Molding - Repair mark - Yes / (R) Front Fender, Molding - Rust, Corrosion - Large / (R) Mirror - Scratch - Small / (R) Front Door, Molding - Scratch & Dent - Medium / (R) Step, In-panel, Side Spoiler - Scratch & Dent - Small / (R) Rear Door, Molding - Scratch & Dent - Large / (R) Rear Fender, Molding - Scratch - Small / Trunk Hood, Rear Gate - Scratch & Dent - Medium / Rear Bumper, Lamps, Panels - Scratch - Medium / (L) Rear Fender, Molding - Scratch - Small / (L) Rear Door, Molding - Scratch - Medium / (L) Step, In-panel, Side Spoiler - Scratch - Small / (L) Front Door, Molding - Scratch - Small / (L) Mirror - Scratch - Minimal / (L) Front Fender, Molding - Scratch - Minimal / Front Bumper, Grille, Lamps - Crack, Gap - Medium / Roof - Dent - Minimal / Bonnet, Headlight - Scratch - Minimal</p>
