General Information

Make	Toyota	Model	Raize
YOM	2024	Odo Meter Reading	10,666
Registration No.	NIR2360	Chassis No.	MHKAB1BA4PJ062425
CC	1.2	Transmission	M/T
Fuel Type	Gas	Type of Body	SUV
Colour	Gray

Body / Panel Condition

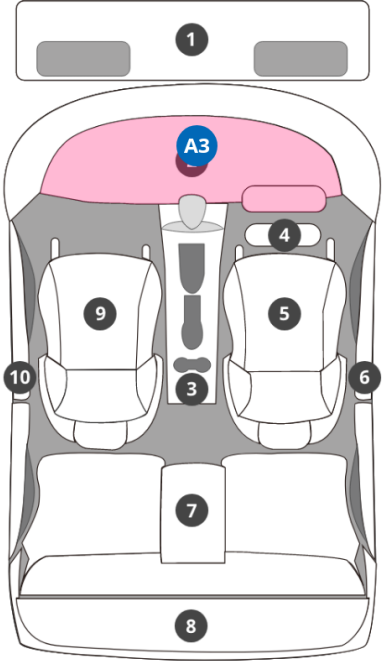
Interior Evaluation : B	Exterior Evaluation : E

<p>A : Scratch AU : Scratch & Dent B : Modified C : Corrosion G : Stone chip P : Faded S : Rust SC : Rust & Corrosion U : Dent X : Defective Y : Crack, Gap</p>
Remarks Dashboard - Worn, Scratch, Cut, Crack - Medium	Remarks (R) Front Door - Repair Traces - Yes / (R) Step - Repair Traces - Yes / (R) Front Fender - Repair Traces - Yes / Bonnet - Repair Traces - Yes / (L) Front Fender - Repair Traces - Yes / (L) Front Door - Repair Traces - Yes / (L) Rear Door - Repair Traces - Yes / (L) Rear Fender - Repair Traces - Yes / Trunk Hood, Rear Gate - Repair Traces - Yes / (R) Rear Fender - Repair Traces - Yes / (R) Rear Door - Repair Traces - Yes / Roof - Repair Traces - Yes / Overall Exterior - Full Re-Paint in same color - Yes / (R) Front Fender, Molding - Repair mark - Yes / (R) Front Fender, Molding - Partially Missing - Yes / (R) Mirror - Crack - Cracks / (R) Front Door, Molding - Scratch - Small / (R) Step, In-panel, Side Spoiler - Scratch - Minimal / (R) Step, In-panel, Side Spoiler - Repair mark - Difference in Color / (R) Rear Fender, Molding - Scratch - Large / Rear Bumper, Lamps, Panels - Scratch & Dent - Medium / Trunk Hood, Rear Gate - Scratch & Dent - Minimal / (L) Rear Fender, Molding - Scratch - Minimal / (L) Rear Door, Molding - Scratch - Minimal / (L) Front Door, Molding - Scratch - Minimal / (L) Mirror - Crack - Cracks / (L) Front Fender, Molding - Scratch & Dent - Minimal / Front Bumper, Grille, Lamps - Repair mark - Yes / Roof - Scratch - Minimal / Bonnet, Headlight - Repair mark - Yes / Front Bumper, Grille, Lamps - Crack, Gap - Medium
