## General Information

<b>Make</b>	Honda	<b>Model</b>	Brio
<b>YOM</b>	2019	<b>Odo Meter Reading</b>	60,895
<b>Registration No.</b>	NDM2053	<b>Chassis No.</b>	MHRDD1870KJ000522
<b>CC</b>	1.2	<b>Transmission</b>	A/T
<b>Fuel Type</b>	Gas	<b>Type of Body</b>	Hatchback
<b>Colour</b>	White

## Body / Panel Condition

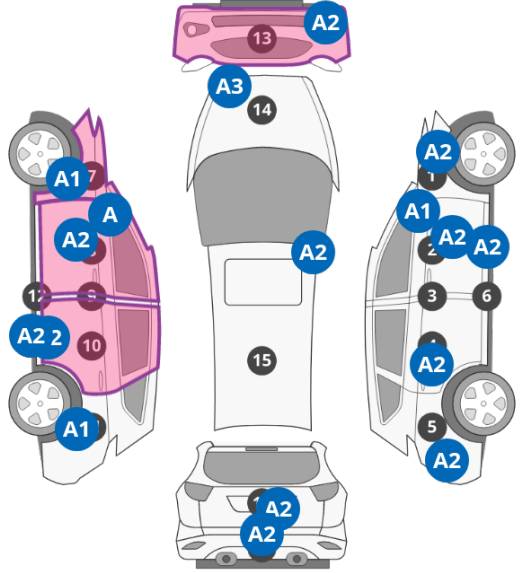
<p><b>A</b> : Scratch <b>AU</b> : Scratch &amp; Dent <b>B</b> : Modified <b>C</b> : Corrosion <b>G</b> : Stone chip <b>P</b> : Faded <b>S</b> : Rust <b>SC</b> : Rust &amp; Corrosion <b>U</b> : Dent <b>X</b> : Defective <b>Y</b> : Crack, Gap</p>
<b>Remarks</b> (R) Front Seat - Grime - Small	<b>Remarks</b> (R) Front Door - Repair Traces - Yes / (R) Front Fender - Repair Traces - Yes / Bonnet - Repair Traces - Yes / (L) Front Fender - Repair Traces - Yes / (L) Front Door - Repair Traces - Yes / (L) Step - Repair Traces - Yes / (L) Rear Door - Repair Traces - Yes / (L) Rear Fender - Repair Traces - Yes / Trunk Hood, Rear Gate - Repair Traces - Yes / (R) Rear Fender - Repair Traces - Yes / (R) Rear Door - Repair Traces - Yes / Roof - Repair Traces - Yes / (R) Front Fender, Molding - Scratch - Small / (R) Mirror - Scratch - Minimal / (R) Front Door, Molding - Scratch - Small / (R) Rear Door, Molding - Scratch - Small / (R) Step, In-panel, Side Spoiler - Scratch - Small / (R) Rear Fender, Molding - Scratch - Small / Trunk Hood, Rear Gate - Scratch - Small / Rear Bumper, Lamps, Panels - Scratch - Small / (L) Rear Door, Molding - Repair mark - Difference in Color / (L) Rear Door, Molding - Scratch - Small / (L) Rear Fender, Molding - Scratch - Minimal / (L) Front Door, Molding - Repair mark - Difference in Color / (L) Mirror - Scratch, Peeled - Yes / (L) Step, In-panel, Side Spoiler - Scratch - Small / (L) Front Fender, Molding - Repair mark - Difference in Color / Front Bumper, Grille, Lamps - Repair mark - Difference in Color / (L) Front Door, Molding - Scratch - Small / (L) Front Fender, Molding - Scratch - Minimal / Bonnet, Headlight - Scratch - Medium / Front Bumper, Grille, Lamps - Scratch - Small / Roof - Scratch - Small
