## General Information

<b>Make</b>	Hyundai	<b>Model</b>	Accent
<b>YOM</b>	2018	<b>Odo Meter Reading</b>	68,531
<b>Registration No.</b>	DAD3594	<b>Chassis No.</b>	KMHCT41BAJU419862
<b>CC</b>	1.4	<b>Transmission</b>	M/T
<b>Fuel Type</b>	Gas	<b>Type of Body</b>	Sedan
<b>Colour</b>	Black

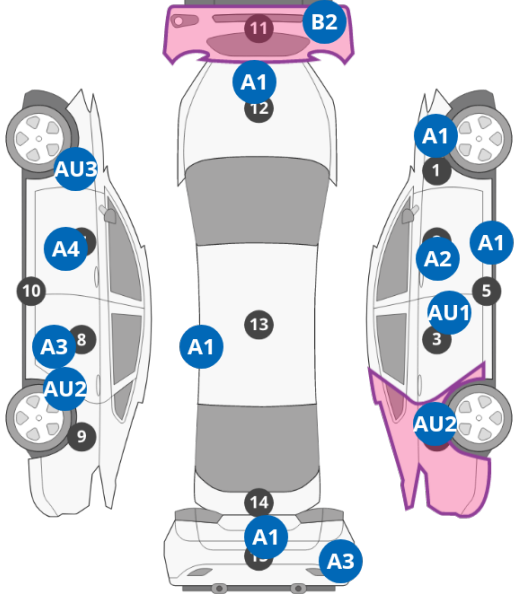
<p><b>A</b> : Scratch <b>AU</b> : Scratch &amp; Dent <b>B</b> : Modified <b>C</b> : Corrosion <b>G</b> : Stone chip <b>P</b> : Faded <b>S</b> : Rust <b>SC</b> : Rust &amp; Corrosion <b>U</b> : Dent <b>X</b> : Defective <b>Y</b> : Crack, Gap</p>
<p><b>Remarks</b> Room Lamp - Missing - Yes / (L) Front Floor Mat - Cut, Crack - Small / (R) Front Trim - Grime - Small / Trunk Room - Loose, Deformed - Large / (L) Rear Trim - Grime - Small / (L) Front Trim - Grime - Small</p>	<p><b>Remarks</b> (L) Front Door - Repair Traces - Yes / Trunk Hood, Rear Gate - Repair Traces - Yes / Roof - Repair Traces - Yes / (R) Front Fender, Molding - Scratch - Minimal / (R) Front Door, Molding - Scratch - Small / (R) Step, In-panel, Side Spoiler - Scratch - Minimal / (R) Rear Door, Molding - Scratch &amp; Dent - Minimal / (R) Rear Fender, Molding - Scratch &amp; Dent - Small / (R) Rear Fender, Molding - Repair mark - Yes / Rear Bumper, Lamps, Panels - Scratch - Medium / Trunk Hood, Rear Gate - Scratch - Minimal / (L) Rear Fender, Molding - Scratch &amp; Dent - Small / (L) Rear Door, Molding - Scratch - Medium / (L) Front Door, Molding - Scratch - Large / (L) Front Fender, Molding - Scratch &amp; Dent - Medium / Front Bumper, Grille, Lamps - Repair mark - Yes / Front Bumper, Grille, Lamps - Modified - Small / Bonnet, Headlight - Scratch - Minimal / Roof - Scratch - Minimal</p>
