## General Information

<b>Make</b>	Suzuki	<b>Model</b>	Swift
<b>YOM</b>	2021	<b>Odo Meter Reading</b>	59,910
<b>Registration No.</b>	FAF6895	<b>Chassis No.</b>	MMSZC63S2MR101275
<b>CC</b>	1.2	<b>Transmission</b>	A/T
<b>Fuel Type</b>	Gas	<b>Type of Body</b>	Hatchback
<b>Colour</b>	Red

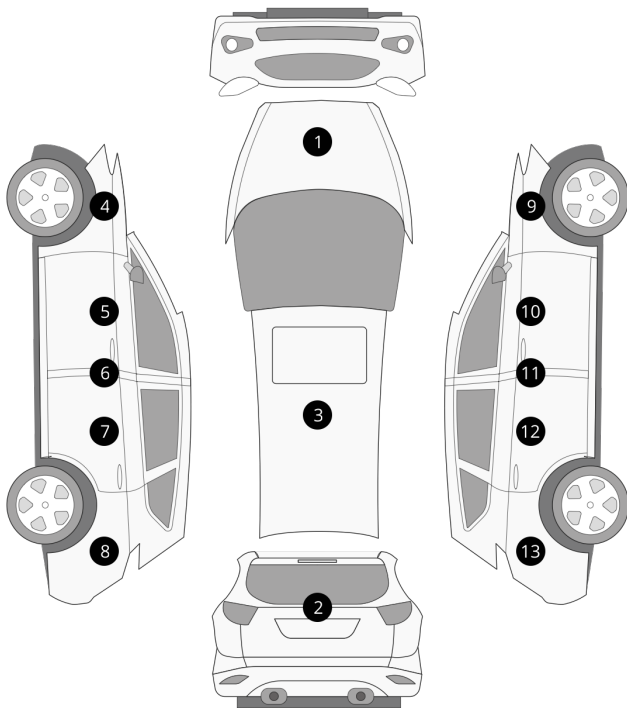
## Body / Panel Condition

#	Area	Thickness(um)			
		Average	Value1	Value2	Value3/4
1	Bonnet	102.0	92	110	104
2	Boot Lid	111.0	106	112	115
3	Roof	175.7	202	100	207/194
4	Left Front Fender	105.0	100	103	112
5	Left Front Door	112.6	120	112	106
6	Center Panel Left				
7	Left Rear Door	106.5	119	101	100
8	Left Back Panel	180.3	132	131	278
9	Right Front Fender	102.2	122	91	94
10	Right Front Door	150.3	140	155	156
11	Center Panel Right				
12	Right Rear Door	104.1	97	101	114
13	Right Back Panel	113.6	117	108	116

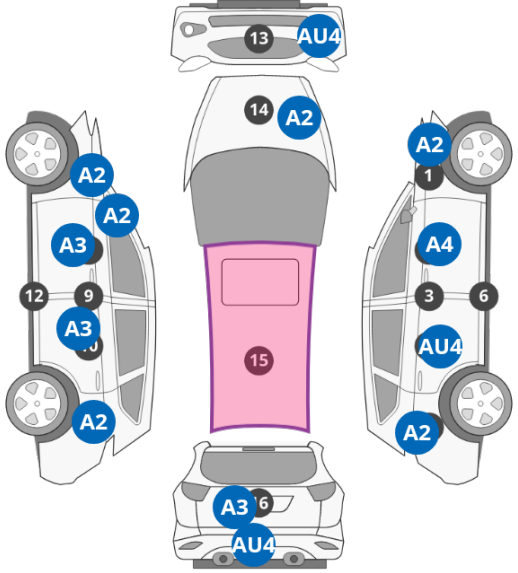
<p><b>A</b> : Scratch <b>AU</b> : Scratch &amp; Dent <b>B</b> : Modified <b>C</b> : Corrosion <b>G</b> : Stone chip <b>P</b> : Faded <b>S</b> : Rust <b>SC</b> : Rust &amp; Corrosion <b>U</b> : Dent <b>X</b> : Defective <b>Y</b> : Crack, Gap</p>
<p><b>Remarks</b> (L) Front Trim - Grime - Small / (L) Front Floor Mat - Worked - Small / (L) Front Seat - Grime - Medium / Mat Other - Grime - Small / Rear Seat - Grime - Large / Trunk Room - Loose, Deformed - Large / (R) Front Trim - Grime - Small / (R) Front Seat - Grime - Medium / (R) Front Floor Mat - Grime - Small / Ceiling - Grime - Medium / Sunvisor, Sunglass Holder - Grime - Small</p>	<p><b>Remarks</b> (L) Rear Fender - Repair Traces - Yes / Roof - Repair Traces - Yes / Roof - Repair mark - Difference in Color / (L) Front Fender, Molding - Scratch - Small / (L) Mirror - Scratch - Small / (L) Rear Door, Molding - Scratch - Medium / (L) Front Door, Molding - Scratch - Medium / (L) Rear Fender, Molding - Scratch - Small / Trunk Hood, Rear Gate - Scratch - Medium / Rear Bumper, Lamps, Panels - Scratch &amp; Dent - Large / (R) Rear Fender, Molding - Scratch - Small / (R) Rear Door, Molding - Scratch &amp; Dent - Large / (R) Front Door, Molding - Scratch - Large / (R) Front Fender, Molding - Scratch - Small / Front Bumper, Grille, Lamps - Scratch &amp; Dent - Large / Bonnet, Headlight - Scratch - Small</p>
