## General Information

Date & Time: 20, Jan, 2026 16:35

<b>Make</b>	Toyota	<b>Model</b>	Avanza
<b>YOM</b>	2024	<b>Odo Meter Reading</b>	14,552
<b>Registration No.</b>	GBC9543	<b>Chassis No.</b>	MHFAA1BY1P0021643
<b>CC</b>	1.3	<b>Transmission</b>	CVT
<b>Fuel Type</b>	Gas	<b>Type of Body</b>	MPV
<b>Colour</b>	Green

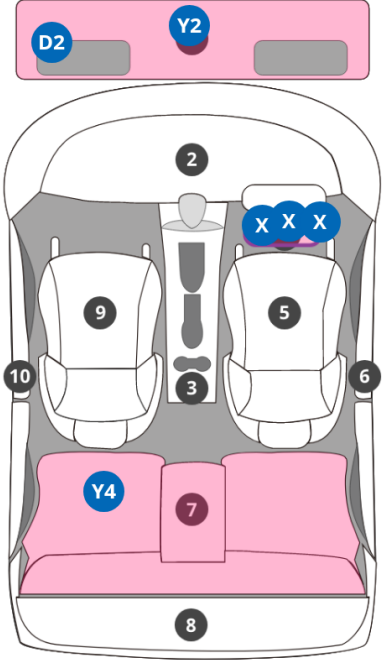
<b>Interior Evaluation :</b> <span style="float: right; color: red; font-weight: bold;">C</span>	<b>Exterior Evaluation :</b> <span style="float: right; color: red; font-weight: bold;">E</span>

<p><b>a</b> : Cut, Fray <b>d</b> : Loose, Deformed <b>k</b> : Animal Hair <b>s</b> : Smell <b>t</b> : Cigarette Burns <b>x</b> : Defective <b>y</b> : Stain</p>

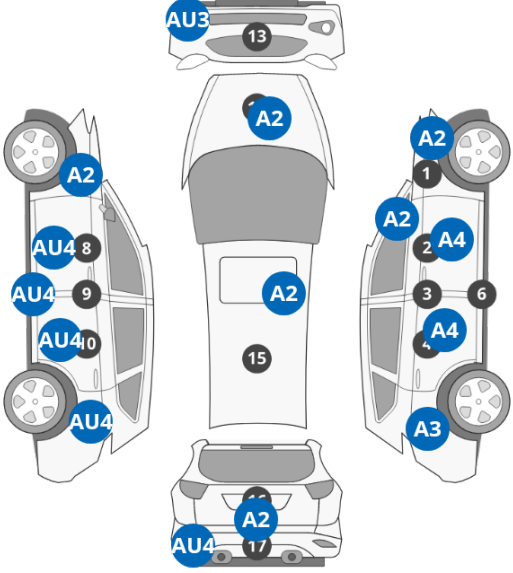
<p><b>A</b> : Scratch <b>AU</b> : Scratch &amp; Dent <b>B</b> : Modified <b>C</b> : Corrosion <b>G</b> : Stone chip <b>P</b> : Faded <b>S</b> : Rust <b>SC</b> : Rust &amp; Corrosion <b>U</b> : Dent <b>X</b> : Defective <b>Y</b> : Crack, Gap</p>
<p><b>Remarks</b> (L) Front Floor Mat - Missing - Yes / Sunvisor, Sunglass Holder - Crinkle - Small / Ceiling - Grime - Small / Mat Other - Missing - Yes / Rear Seat - Grime - Large / (R) Front Floor Mat - Missing - Yes</p>	<p><b>Remarks</b> (R) Front Door - Repair Traces - Yes / (R) Step - Repair Traces - Yes / Bonnet, Headlight - Scratch - Small / (L) Front Fender, Molding - Scratch - Small / (L) Front Door, Molding - Scratch &amp; Dent - Large / (L) Step, In-panel, Side Spoiler - Scratch &amp; Dent - Large / (L) Rear Door, Molding - Scratch &amp; Dent - Large / (L) Rear Fender, Molding - Scratch &amp; Dent - Large / Trunk Hood, Rear Gate - Scratch - Small / Rear Bumper, Lamps, Panels - Scratch &amp; Dent - Large / (R) Rear Fender, Molding - Scratch - Medium / (R) Rear Door, Molding - Scratch - Large / (R) Front Door, Molding - Scratch - Large / (R) Mirror - Scratch - Small / (R) Front Fender, Molding - Scratch - Small / Front Bumper, Grille, Lamps - Scratch &amp; Dent - Medium / Roof - Scratch - Small</p>
