## General Information

<b>Make</b>	Toyota	<b>Model</b>	Hilux
<b>YOM</b>	2021	<b>Odo Meter Reading</b>	65,741
<b>Registration No.</b>	NEW4113	<b>Chassis No.</b>	MR0JB8DD2M3181618
<b>CC</b>	2.4	<b>Transmission</b>	A/T
<b>Fuel Type</b>	Diesel	<b>Type of Body</b>	Pickup
<b>Colour</b>	White

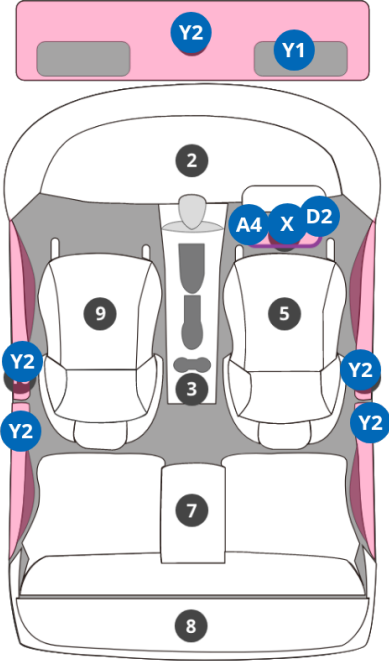
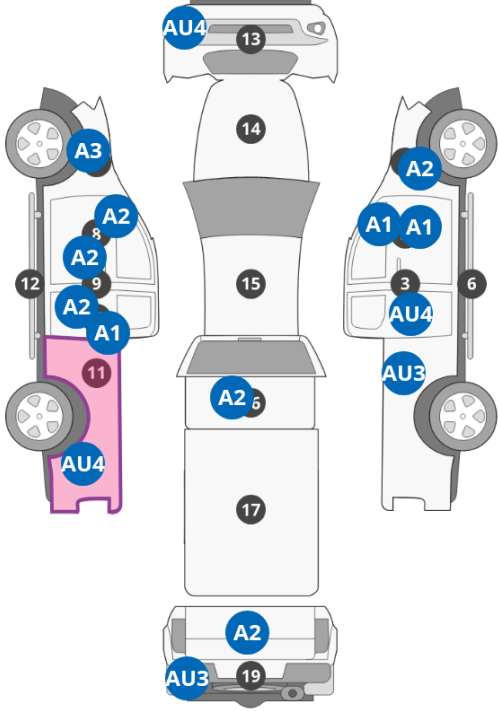
<b>Interior Evaluation :</b>	C	<b>Exterior Evaluation :</b>	E

<p><b>a</b> : Cut, Fray <b>d</b> : Loose, Deformed <b>k</b> : Animal Hair <b>s</b> : Smell <b>t</b> : Cigarette Burns <b>x</b> : Defective <b>y</b> : Stain</p>		<p><b>A</b> : Scratch <b>AU</b> : Scratch &amp; Dent <b>B</b> : Modified <b>C</b> : Corrosion <b>G</b> : Stone chip <b>P</b> : Faded <b>S</b> : Rust <b>SC</b> : Rust &amp; Corrosion <b>U</b> : Dent <b>X</b> : Defective <b>Y</b> : Crack, Gap</p>	
<p><b>Remarks</b> (R) Front Trim - Grime - Small / Sunvisor, Sunglass Holder - Grime - Minimal / Ceiling - Grime - Small / Mat Other - Missing - Yes / (R) Rear Trim - Grime - Small / (L) Rear Trim - Grime - Small / (L) Front Floor Mat - Cut, Crack - Large / (L) Front Trim - Grime - Small / (R) Front Floor Mat - Worked - Small</p>		<p><b>Remarks</b> (R) Rear Door, Molding - Scratch &amp; Dent - Large / (R) Front Door, Molding - Scratch - Minimal / (R) Mirror - Scratch - Minimal / (R) Front Fender, Molding - Scratch - Small / Front Bumper, Grille, Lamps - Scratch &amp; Dent - Large / (L) Front Fender, Molding - Scratch - Medium / (L) Mirror - Scratch - Small / (L) Front Door, Molding - Scratch - Small / (L) Rear Door, Molding - Scratch - Small / (L) Rear Corner Panel - Scratch - Minimal / (L) Side Gate - Scratch &amp; Dent - Large / Rear Gate - Scratch - Small / (R) Side Gate - Scratch &amp; Dent - Medium / Rear Bumper, Lamps, Panels - Scratch &amp; Dent - Medium / Cab Back Panel - Scratch - Small / (L) Rear Wheel, Cover - Cap Missing - Yes</p>
