## General Information

Date & Time: 20, Jan, 2026 18:21

<b>Make</b>	Toyota	<b>Model</b>	Innova
<b>YOM</b>	2025	<b>Odo Meter Reading</b>	27,007
<b>Registration No.</b>	GBD6945	<b>Chassis No.</b>	PA2JA8EM7R0145352
<b>CC</b>	2.8	<b>Transmission</b>	A/T
<b>Fuel Type</b>	Diesel	<b>Type of Body</b>	Wagon
<b>Colour</b>	Blackish Red Mica

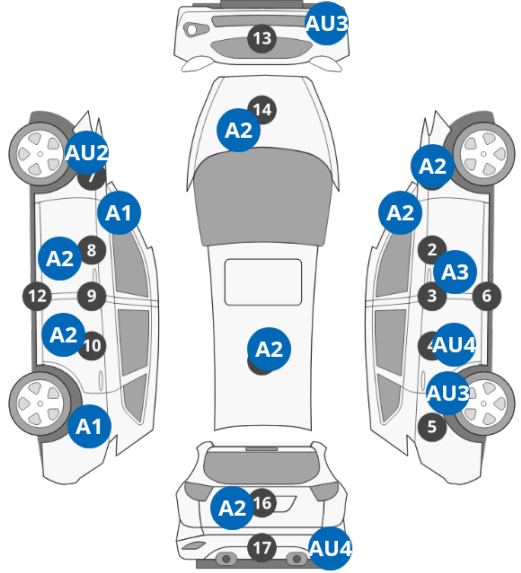
<p><b>A</b> : Scratch <b>AU</b> : Scratch &amp; Dent <b>B</b> : Modified <b>C</b> : Corrosion <b>G</b> : Stone chip <b>P</b> : Faded <b>S</b> : Rust <b>SC</b> : Rust &amp; Corrosion <b>U</b> : Dent <b>X</b> : Defective <b>Y</b> : Crack, Gap</p>
<p><b>Remarks</b> (L) Front Trim - Grime - Medium / (L) Front Floor Mat - Worked - Small / Ceiling - Grime - Small / (L) Rear Trim - Grime - Small / Mat Other - Grime - Large / Overall Interior - Smell - Yes / (R) Rear Trim - Grime - Small / (R) Front Trim - Grime - Small / (R) Front Floor Mat - Grime - Medium / Console, Switches, Vents - Traces of Adhesive Tape - Yes</p>	<p><b>Remarks</b> Bonnet, Headlight - Scratch - Small / (L) Front Fender, Molding - Scratch &amp; Dent - Small / (L) Mirror - Scratch - Minimal / (L) Front Door, Molding - Scratch - Small / (L) Rear Door, Molding - Scratch - Small / (L) Rear Fender, Molding - Scratch - Minimal / Trunk Hood, Rear Gate - Scratch - Small / Rear Bumper, Lamps, Panels - Scratch &amp; Dent - Large / (R) Rear Fender, Molding - Scratch &amp; Dent - Medium / (R) Rear Door, Molding - Scratch &amp; Dent - Large / (R) Front Door, Molding - Scratch - Medium / (R) Mirror - Scratch - Small / (R) Front Fender, Molding - Scratch - Small / Front Bumper, Grille, Lamps - Scratch &amp; Dent - Medium / Roof - Scratch - Small</p>
