## General Information

<b>Make</b>	Toyota	<b>Model</b>	Raize
<b>YOM</b>	2025	<b>Odo Meter Reading</b>	6,764
<b>Registration No.</b>	GBK8304	<b>Chassis No.</b>	MHKAB1BA3SJ126124
<b>CC</b>	1.2	<b>Transmission</b>	CVT
<b>Fuel Type</b>	Gas	<b>Type of Body</b>	SUV
<b>Colour</b>	Gray

## Body / Panel Condition

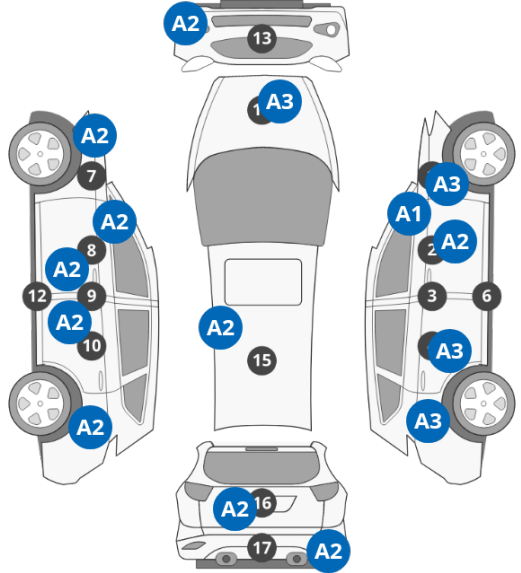
<p><b>A</b> : Scratch <b>AU</b> : Scratch &amp; Dent <b>B</b> : Modified <b>C</b> : Corrosion <b>G</b> : Stone chip <b>P</b> : Faded <b>S</b> : Rust <b>SC</b> : Rust &amp; Corrosion <b>U</b> : Dent <b>X</b> : Defective <b>Y</b> : Crack, Gap</p>
<p><b>Remarks</b> (R) Front Floor Mat - Grime - Medium / Rear Seat - Grime - Large / Mat Other - Grime - Medium / Ceiling - Grime - Small / Sunvisor, Sunglass Holder - Grime - Small / (L) Front Floor Mat - Worked - Small</p>	<p><b>Remarks</b> (L) Mirror - Scratch - Small / (L) Front Fender, Molding - Scratch - Small / (L) Front Door, Molding - Scratch - Small / (L) Rear Door, Molding - Scratch - Small / (L) Rear Fender, Molding - Scratch - Small / (R) Rear Fender, Molding - Scratch - Medium / Trunk Hood, Rear Gate - Scratch - Small / Rear Bumper, Lamps, Panels - Scratch - Small / (R) Rear Door, Molding - Scratch - Medium / (R) Front Door, Molding - Scratch - Small / (R) Front Fender, Molding - Scratch - Medium / (R) Mirror - Scratch - Minimal / Bonnet, Headlight - Scratch - Medium / Front Bumper, Grille, Lamps - Scratch - Small / Roof - Scratch - Small</p>
