## General Information

Date & Time: 21, Jan, 2026 10:26

<b>Make</b>	Toyota	<b>Model</b>	Vios
<b>YOM</b>	2024	<b>Odo Meter Reading</b>	33,093
<b>Registration No.</b>	CCA6416	<b>Chassis No.</b>	PA1B18F30R4244750
<b>CC</b>	1.3	<b>Transmission</b>	CVT
<b>Fuel Type</b>	Gas	<b>Type of Body</b>	Sedan
<b>Colour</b>	Red Mica Metallic

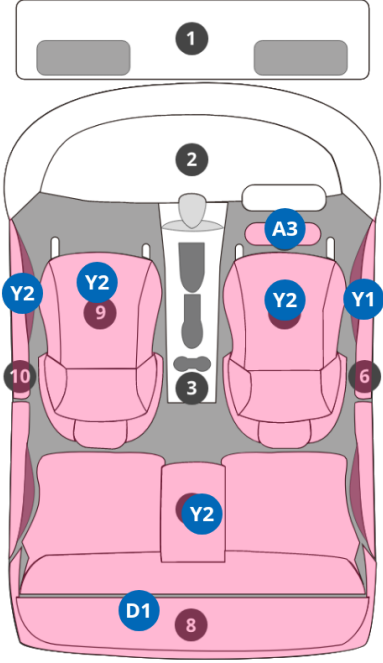
<b>Interior Evaluation :</b> <span style="float: right;"><b>B</b></span>	<b>Exterior Evaluation :</b> <span style="float: right;"><b>D</b></span>

<p><b>a</b> : Cut, Fray <b>d</b> : Loose, Deformed <b>k</b> : Animal Hair <b>s</b> : Smell <b>t</b> : Cigarette Burns <b>x</b> : Defective <b>y</b> : Stain</p>

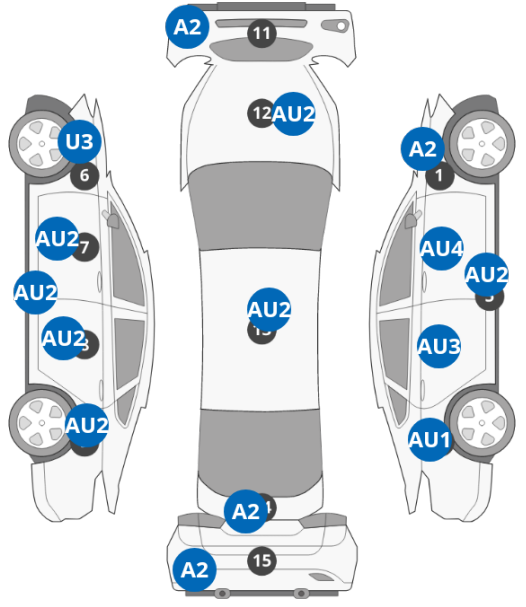
<p><b>A</b> : Scratch <b>AU</b> : Scratch &amp; Dent <b>B</b> : Modified <b>C</b> : Corrosion <b>G</b> : Stone chip <b>P</b> : Faded <b>S</b> : Rust <b>SC</b> : Rust &amp; Corrosion <b>U</b> : Dent <b>X</b> : Defective <b>Y</b> : Crack, Gap</p>
<p><b>Remarks</b> (L) Front Floor Mat - Cut, Crack - Medium / (R) Front Seat - Grime - Small / (L) Front Seat - Grime - Small / Rear Seat - Grime - Small / (L) Front Trim - Grime - Small / (R) Front Trim - Grime - Minimal / Trunk Room - Worked - Minimal</p>	<p><b>Remarks</b> (L) Front Fender, Molding - Dent - Medium / (L) Front Door, Molding - Scratch &amp; Dent - Small / (L) Rear Door, Molding - Scratch &amp; Dent - Small / (L) Step, In-panel, Side Spoiler - Scratch &amp; Dent - Small / (L) Rear Fender, Molding - Scratch &amp; Dent - Small / Trunk Hood, Rear Gate - Scratch - Small / Rear Bumper, Lamps, Panels - Scratch - Small / (R) Rear Fender, Molding - Scratch &amp; Dent - Minimal / (R) Rear Door, Molding - Scratch &amp; Dent - Medium / (R) Step, In-panel, Side Spoiler - Scratch &amp; Dent - Small / (R) Front Door, Molding - Scratch &amp; Dent - Large / Roof - Scratch &amp; Dent - Small / (R) Front Fender, Molding - Scratch - Small / Bonnet, Headlight - Scratch &amp; Dent - Small / Front Bumper, Grille, Lamps - Scratch - Small</p>
