## General Information

<b>Make</b>	Toyota	<b>Model</b>	Fortuner
<b>YOM</b>	2021	<b>Odo Meter Reading</b>	51,527
<b>Registration No.</b>	NEO3115	<b>Chassis No.</b>	MHFCB8GS8M0520308
<b>CC</b>	2.4	<b>Transmission</b>	A/T
<b>Fuel Type</b>	Diesel	<b>Type of Body</b>	SUV
<b>Colour</b>	White

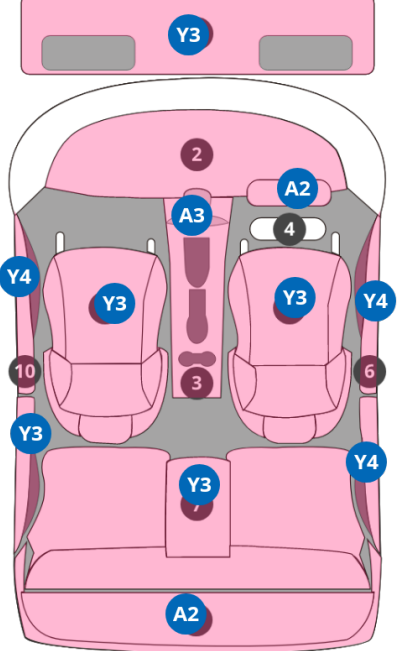
<b>Interior Evaluation :</b> <span style="float: right;"><b>E</b></span>	<b>Exterior Evaluation :</b> <span style="float: right;"><b>E</b></span>

<p><b>A</b> : Scratch <b>AU</b> : Scratch &amp; Dent <b>B</b> : Modified <b>C</b> : Corrosion <b>G</b> : Stone chip <b>P</b> : Faded <b>S</b> : Rust <b>SC</b> : Rust &amp; Corrosion <b>U</b> : Dent <b>X</b> : Defective <b>Y</b> : Crack, Gap</p>
<p><b>Remarks</b> (R) Front Seat - Grime - Medium / (R) Front Trim - Grime - Large / (R) Rear Trim - Grime - Large / Rear Seat - Grime - Medium / Trunk Room - Worn, Scratch, Cut, Crack - Small / (L) Rear Trim - Grime - Medium / (L) Front Trim - Grime - Large / (L) Front Seat - Grime - Medium / Ceiling - Grime - Medium / Steering Wheel - Worn, Peel, Crack - Small / Console, Switchs, Vents - Worn, Scratch, Cut, Crack - Medium</p>	<p><b>Remarks</b> (L) Front Fender, Molding - Scratch - Small / (L) Front Door, Molding - Scratch &amp; Dent - Small / (L) Rear Door, Molding - Scratch - Medium / (L) Rear Fender, Molding - Scratch - Small / Rear Bumper, Lamps, Panels - Scratch - Large / Trunk Hood, Rear Gate - Scratch - Medium / Front Bumper, Grille, Lamps - Scratch - Medium / Bonnet, Headlight - Scratch - Small / (R) Front Fender, Molding - Scratch - Small / (R) Front Door, Molding - Rust, Corrosion - Medium / (R) Rear Door, Molding - Scratch &amp; Dent - Small / (R) Rear Fender, Molding - Scratch - Medium / Roof - Scratch - Small</p>
