General Information

| Make | Hyundai | Model | Accent |
| Registration No. | FAH1890 | Chassis No. | KMHCT41BAKU457721 |

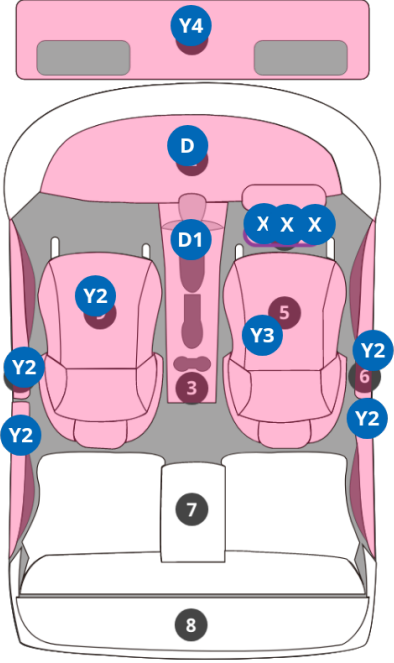
| Interior Evaluation : C | Exterior Evaluation : E |

| <p>Remarks (L) Front Floor Mat - Missing - Yes / (R) Front Floor Mat - Missing - Yes / Mat Other - Missing - Yes / (L) Front Trim - Grime - Small / Dashboard - Traces of Adhesive Tape - Yes / (L) Front Seat - Grime - Small / (L) Rear Trim - Grime - Small / Ceiling - Grime - Large / (R) Rear Trim - Grime - Small / (R) Front Trim - Grime - Small / (R) Front Seat - Grime - Medium / Console, Switches, Vents - Worked - Minimal</p> | <p>Remarks (R) Front Door - Repair Traces - Yes / (R) Step - Repair Traces - Yes / (R) Rear Fender - Repair Traces - Yes / (R) Rear Door - Repair Traces - Yes / Bonnet, Headlight - Scratch & Dent - Small / (R) Front Fender, Molding - Scratch - Small / (R) Mirror - Scratch - Minimal / (R) Rear Fender, Molding - Repair mark - Yes / (R) Step, In-panel, Side Spoiler - Scratch - Small / (R) Rear Door, Molding - Scratch & Dent - Medium / (R) Front Door, Molding - Scratch - Small / (R) Rear Door, Molding - Repair mark - Yes / Trunk Hood, Rear Gate - Scratch - Small / Rear Bumper, Lamps, Panels - Scratch & Dent - Medium / (L) Rear Fender, Molding - Scratch - Small / Roof - Scratch & Dent - Medium / (L) Rear Door, Molding - Scratch - Small / (L) Front Door, Molding - Scratch - Small / (L) Step, In-panel, Side Spoiler - Scratch & Dent - Small / (L) Front Fender, Molding - Scratch - Small / (L) Mirror - Scratch - Minimal / Front Bumper, Grille, Lamps - Scratch & Dent - Medium</p> |
