General Information

Date & Time: 20, Jan, 2026 13:58

Make	Toyota	Model	Wigo
YOM	2025	Odo Meter Reading	22,992
Registration No.	HAG8752	Chassis No.	MHKAA1BC4RJ026029
CC	1.0	Transmission	CVT
Fuel Type	Gas	Type of Body	Hatchback
Colour	Red Mica Metallic

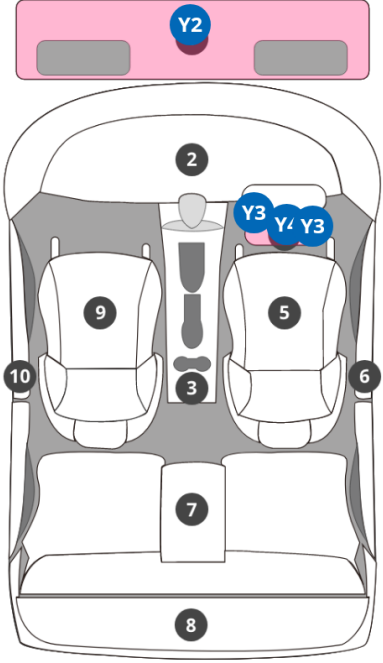
Interior Evaluation : C	Exterior Evaluation : E

<p>a : Cut, Fray d : Loose, Deformed k : Animal Hair s : Smell t : Cigarette Burns x : Defective y : Stain</p>

<p>A : Scratch AU : Scratch & Dent B : Modified C : Corrosion G : Stone chip P : Faded S : Rust SC : Rust & Corrosion U : Dent X : Defective Y : Crack, Gap</p>
<p>Remarks (L) Front Floor Mat - Grime - Medium / Ceiling - Grime - Small / Mat Other - Grime - Large / (R) Front Floor Mat - Grime - Medium</p>	<p>Remarks (R) Front Door - Repair Traces - Yes / (R) Step - Repair Traces - Yes / (R) Rear Door - Repair Traces - Yes / (R) Front Door, Molding - Repair mark - Yes / (R) Rear Door, Molding - Repair mark - Yes / Bonnet, Headlight - Scratch - Large / (L) Front Fender, Molding - Scratch - Small / (L) Mirror - Scratch - Small / (L) Rear Door, Molding - Scratch - Medium / (L) Front Door, Molding - Scratch - Small / (L) Rear Fender, Molding - Scratch - Small / (R) Rear Fender, Molding - Scratch - Small / Trunk Hood, Rear Gate - Scratch - Small / Rear Bumper, Lamps, Panels - Scratch - Medium / Roof Spoiler, Molding - Scratch - Small / (R) Rear Door, Molding - Scratch - Small / (R) Step, In-panel, Side Spoiler - Scratch & Dent - Medium / (R) Mirror - Faded(Color, Gloss) - Yes / (R) Mirror - Scratch - Small / (R) Front Fender, Molding - Repair mark - Yes / Front Bumper, Grille, Lamps - Scratch & Dent - Medium / Roof - Scratch - Large</p>
