General Information

Date & Time: 20, Jan, 2026 10:06

Make	Toyota	Model	Vios
YOM	2024	Odo Meter Reading	24,207
Registration No.	NEY3374	Chassis No.	PA1B18F36R4256286
CC	1.3	Transmission	CVT
Fuel Type	Gas	Type of Body	Sedan
Colour	Blue

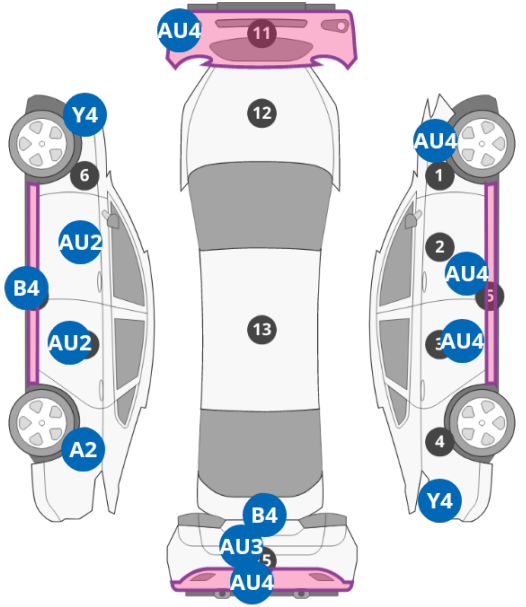
<p>A : Scratch AU : Scratch & Dent B : Modified C : Corrosion G : Stone chip P : Faded S : Rust SC : Rust & Corrosion U : Dent X : Defective Y : Crack, Gap</p>
<p>Remarks (L) Front Trim - Grime - Large / (R) Front Trim - Grime - Medium / Dashboard - Traces of Adhesive Tape - Yes / Rear Seat - Repair Mark - Yes / Overall Interior - Worn as per age - Yes / (L) Front Floor Mat - Cut, Crack - Medium</p>	<p>Remarks (R) Step - Repair Traces - Yes / (R) Front Fender - Repair Traces - Yes / Bonnet - Repair Traces - Yes / (L) Front Fender - Repair Traces - Yes / (L) Step - Repair Traces - Yes / Trunk Hood, Rear Gate - Repair Traces - Yes / (R) Rear Door - Repair Traces - Yes / (R) Front Fender, Molding - Scratch & Dent - Large / (R) Front Door, Molding - Scratch & Dent - Large / (R) Rear Door, Molding - Scratch & Dent - Large / Rear Bumper, Lamps, Panels - Repair mark - Difference in Color / Rear Bumper, Lamps, Panels - Scratch & Dent - Large / Trunk Hood, Rear Gate - Scratch & Dent - Medium / Trunk Hood, Rear Gate - Modified - Large / (R) Rear Fender, Molding - Crack, Gap - Large / (L) Step, In-panel, Side Spoiler - Modified - Large / Front Bumper, Grille, Lamps - Repair mark - Yes / Front Bumper, Grille, Lamps - Scratch & Dent - Large / (L) Front Fender, Molding - Crack, Gap - Large / (L) Front Door, Molding - Scratch & Dent - Small / (L) Rear Door, Molding - Scratch & Dent - Small / (L) Rear Fender, Molding - Scratch - Small / (L) Step, In-panel, Side Spoiler - Repair mark - Yes / (R) Step, In-panel, Side Spoiler - Repair mark - Yes</p>
