General Information

Make	Nissan	Model	Navara
YOM	2019	Odo Meter Reading	88,744
Registration No.	LAD7128	Chassis No.	MNTCC2023Z0055930
CC	2.5	Transmission	M/T
Fuel Type	Diesel	Type of Body	Pickup
Colour	Silver

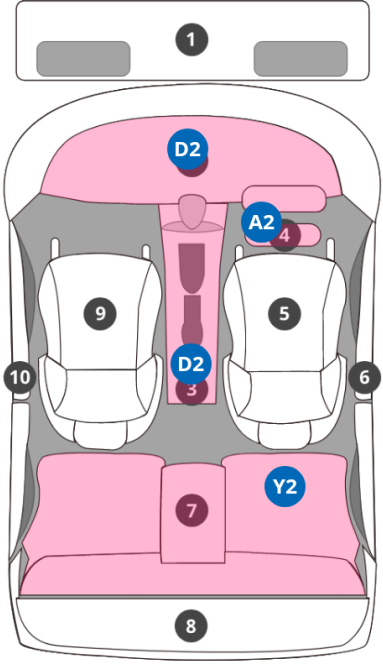
Interior Evaluation : A	Exterior Evaluation : E

<p>a : Cut, Fray d : Loose, Deformed k : Animal Hair s : Smell t : Cigarette Burns x : Defective y : Stain</p>

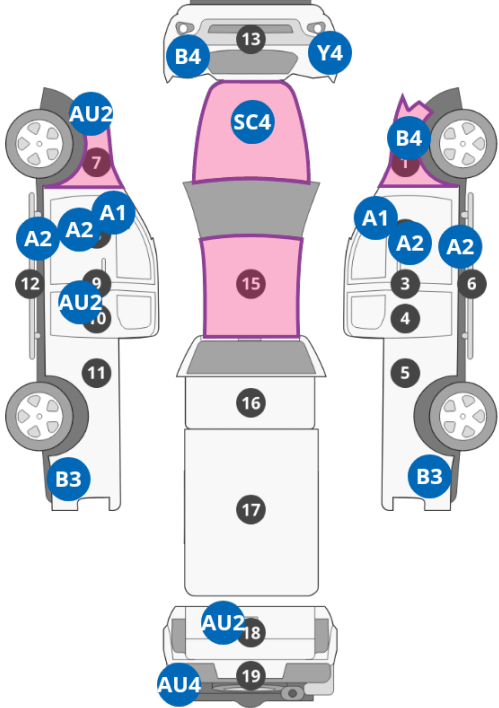
<p>A : Scratch AU : Scratch & Dent B : Modified C : Corrosion G : Stone chip P : Faded S : Rust SC : Rust & Corrosion U : Dent X : Defective Y : Crack, Gap</p>
<p>Remarks Glove Box - Loose, Deformed - Small / Rear Seat - Grime - Small / (L) Front Floor Mat - Cut, Crack - Small / Console, Switchs, Vents - Loose, Deformed - Small</p>	<p>Remarks (R) Front Door - Repair Traces - Yes / (R) Front Fender - Repair Traces - Yes / Bonnet - Repair Traces - Yes / (L) Front Fender - Repair Traces - Yes / (L) Front Door - Repair Traces - Yes / (L) Rear Door - Repair Traces - Yes / (L) Rear Corner Panel - Repair Traces - Yes / (R) Rear Door - Repair Traces - Yes / Roof - Repair Traces - Yes / (R) Front Fender, Molding - Repair mark - Difference in Color / (R) Front Fender, Molding - Modified - Large / (R) Step, In-panel, Side Spoiler - Scratch - Small / (R) Front Door, Molding - Scratch - Small / (R) Mirror - Scratch - Minimal / Overall Exterior - Full Re-Paint in same color - Yes / (R) Side Gate - Modified - Medium / Rear Bumper, Lamps, Panels - Scratch & Dent - Large / Rear Gate - Scratch & Dent - Small / (L) Side Gate - Modified - Medium / Roof - Repair mark - Difference in Color / (L) Rear Door, Molding - Scratch & Dent - Small / (L) Step, In-panel, Side Spoiler - Scratch - Small / (L) Mirror - Scratch - Minimal / (L) Front Door, Molding - Scratch - Small / (L) Front Fender, Molding - Repair mark - Difference in Color / (L) Front Fender, Molding - Scratch & Dent - Small / Front Bumper, Grille, Lamps - Modified - Large / Bonnet, Headlight - Repair mark - Difference in Color / Bonnet, Headlight - Rust, Corrosion - Large / Front Bumper, Grille, Lamps - Crack, Gap - Large</p>
