## General Information

<b>Make</b>	Toyota	<b>Model</b>	Vios
<b>YOM</b>	2023	<b>Odo Meter Reading</b>	103,581
<b>Registration No.</b>	NHJ9982	<b>Chassis No.</b>	PA1B18F34P4221713
<b>CC</b>	1.3	<b>Transmission</b>	CVT
<b>Fuel Type</b>	Gas	<b>Type of Body</b>	Sedan
<b>Colour</b>	Green

## Body / Panel Condition

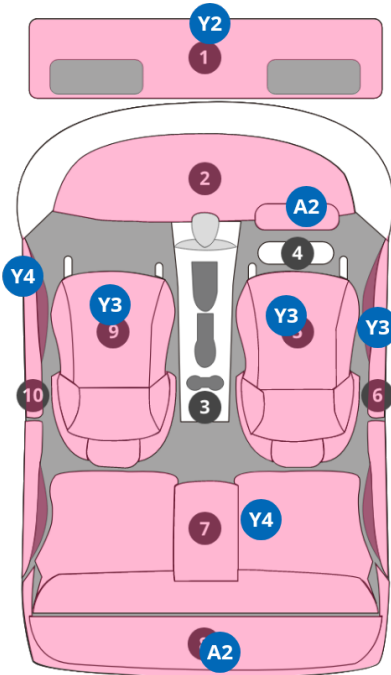
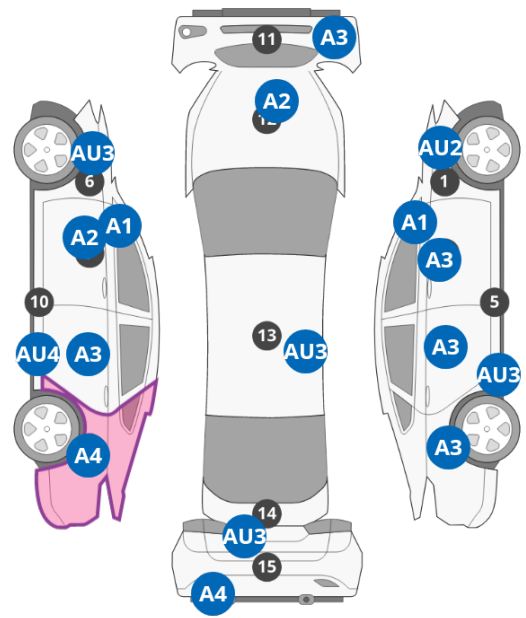
<p><b>a</b> : Cut, Fray <b>d</b> : Loose, Deformed <b>k</b> : Animal Hair <b>s</b> : Smell <b>t</b> : Cigarette Burns <b>x</b> : Defective <b>y</b> : Stain</p>		<p><b>A</b> : Scratch <b>AU</b> : Scratch &amp; Dent <b>B</b> : Modified <b>C</b> : Corrosion <b>G</b> : Stone chip <b>P</b> : Faded <b>S</b> : Rust <b>SC</b> : Rust &amp; Corrosion <b>U</b> : Dent <b>X</b> : Defective <b>Y</b> : Crack, Gap</p>	
<p><b>Remarks</b> (R) Front Seat - Grime - Medium / (R) Front Trim - Grime - Medium / Rear Seat - Grime - Large / Trunk Room - Worn, Scratch, Cut, Crack - Small / (L) Front Trim - Grime - Large / (L) Front Seat - Grime - Medium / Steering Wheel - Worn, Peel, Crack - Small / Ceiling - Grime - Small</p>		<p><b>Remarks</b> (R) Front Door - Repair Traces - Yes / (R) Front Fender - Repair Traces - Yes / Bonnet - Repair Traces - Yes / (L) Rear Fender - Repair Traces - Yes / Trunk Hood, Rear Gate - Repair Traces - Yes / (R) Rear Fender - Repair Traces - Yes / (R) Rear Door - Repair Traces - Yes / Roof - Repair Traces - Yes / Trunk Hood, Rear Gate - Scratch &amp; Dent - Medium / Rear Bumper, Lamps, Panels - Scratch - Large / (L) Rear Fender, Molding - Repair mark - Yes / (L) Rear Fender, Molding - Scratch - Large / (L) Rear Door, Molding - Scratch - Medium / (L) Step, In-panel, Side Spoiler - Scratch &amp; Dent - Large / (L) Front Door, Molding - Scratch - Small / (L) Mirror - Scratch - Minimal / (L) Front Fender, Molding - Scratch &amp; Dent - Medium / Bonnet, Headlight - Scratch - Small / Front Bumper, Grille, Lamps - Scratch - Medium / (R) Front Fender, Molding - Scratch &amp; Dent - Small / (R) Mirror - Scratch - Minimal / (R) Front Door, Molding - Scratch - Medium / (R) Rear Door, Molding - Scratch - Medium / (R) Step, In-panel, Side Spoiler - Scratch &amp; Dent - Medium / (R) Rear Fender, Molding - Scratch - Medium / Roof - Scratch &amp; Dent - Medium</p>
