General Information

| Make | Toyota | Model | Vios |

Body / Panel Condition

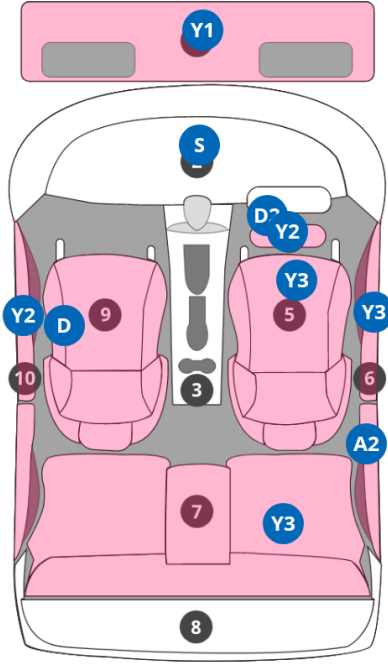
| Interior Evaluation : C | Exterior Evaluation : E |

| <p>Remarks (L) Front Seat - Worn - Yes / (R) Front Seat - Grime - Medium / Rear Seat - Grime - Medium / (R) Front Trim - Grime - Medium / (L) Front Trim - Grime - Small / (R) Rear Trim - Cut, Crack - Small / (L) Front Floor Mat - Worked - Small / Mat Other - Grime - Small / Ceiling - Grime - Minimal / Overall Interior - Smell - Yes</p> | <p>Remarks Trunk Hood, Rear Gate - Repair Traces - Yes / (R) Mirror - Scratch - Small / (R) Front Door, Molding - Scratch & Dent - Large / (R) Step, In-panel, Side Spoiler - Scratch & Dent - Medium / (R) Rear Door, Molding - Scratch & Dent - Medium / (R) Front Fender, Molding - Scratch & Dent - Medium / (R) Rear Fender, Molding - Scratch & Dent - Medium / Rear Bumper, Lamps, Panels - Scratch & Dent - Large / Trunk Hood, Rear Gate - Scratch & Dent - Medium / (L) Rear Fender, Molding - Scratch & Dent - Small / (L) Rear Door, Molding - Scratch - Small / (L) Front Door, Molding - Scratch - Medium / (L) Step, In-panel, Side Spoiler - Dent - Medium / (L) Mirror - Scratch - Minimal / (L) Front Fender, Molding - Scratch - Small / Front Bumper, Grille, Lamps - Scratch - Medium / Bonnet, Headlight - Scratch - Small / Roof - Scratch - Small</p> |

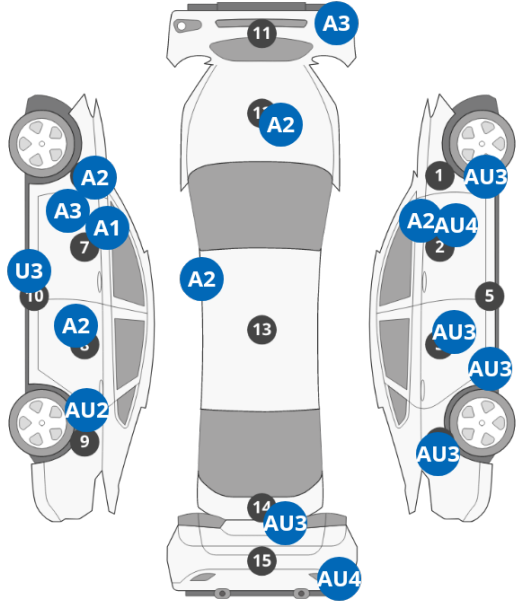
| <p>with warranty booklet and jack, incomplete tools, with spare tire, with LTO plate, possible flooding, scratches on tail light</p> |
