## General Information

<b>Make</b>	Toyota	<b>Model</b>	Avanza
<b>YOM</b>	2024	<b>Odo Meter Reading</b>	42,594
<b>Registration No.</b>	NHM8481	<b>Chassis No.</b>	MHFAA1BY0R0023225
<b>CC</b>	1.3	<b>Transmission</b>	CVT
<b>Fuel Type</b>	Gas	<b>Type of Body</b>	MPV
<b>Colour</b>	Silver

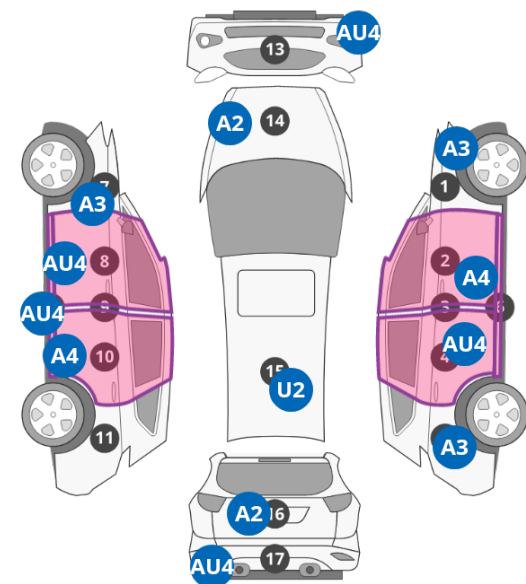
<p><b>A</b> : Scratch <b>AU</b> : Scratch &amp; Dent <b>B</b> : Modified <b>C</b> : Corrosion <b>G</b> : Stone chip <b>P</b> : Faded <b>S</b> : Rust <b>SC</b> : Rust &amp; Corrosion <b>U</b> : Dent <b>X</b> : Defective <b>Y</b> : Crack, Gap</p>
<p><b>Remarks</b> Rear Seat - Grime - Large / (R) Front Trim - Grime - Large / (L) Front Trim - Grime - Large / (L) Front Floor Mat - Worked - Large</p>	<p><b>Remarks</b> (L) Step, In-panel, Side Spoiler - Scratch &amp; Dent - Large / (L) Front Door, Molding - Scratch &amp; Dent - Large / (L) Rear Door, Molding - Scratch - Large / (L) Rear Door, Molding - Repair mark - Yes / (L) Front Door, Molding - Repair mark - Yes / (L) Front Fender, Molding - Scratch - Medium / Front Bumper, Grille, Lamps - Scratch &amp; Dent - Large / (R) Rear Door, Molding - Repair mark - Yes / (R) Front Door, Molding - Repair mark - Yes / (R) Front Fender, Molding - Scratch - Medium / (R) Front Door, Molding - Scratch - Large / (R) Rear Door, Molding - Scratch &amp; Dent - Large / (R) Rear Fender, Molding - Scratch - Medium / Rear Bumper, Lamps, Panels - Scratch &amp; Dent - Large / Trunk Hood, Rear Gate - Scratch - Small / Roof - Dent - Small / Bonnet, Headlight - Scratch - Small / (R) Step, In-panel, Side Spoiler - Repair mark - Yes / (L) Step, In-panel, Side Spoiler - Repair mark - Yes</p>
