## General Information

Date & Time: 21, Jan, 2026 13:24

<b>Make</b>	Honda	<b>Model</b>	CRV
<b>YOM</b>	2018	<b>Odo Meter Reading</b>	19,743
<b>Registration No.</b>	FAD6655	<b>Chassis No.</b>	MRHRW7870JP021236
<b>CC</b>	1.6	<b>Transmission</b>	A/T
<b>Fuel Type</b>	Diesel	<b>Type of Body</b>	SUV
<b>Colour</b>	Silver

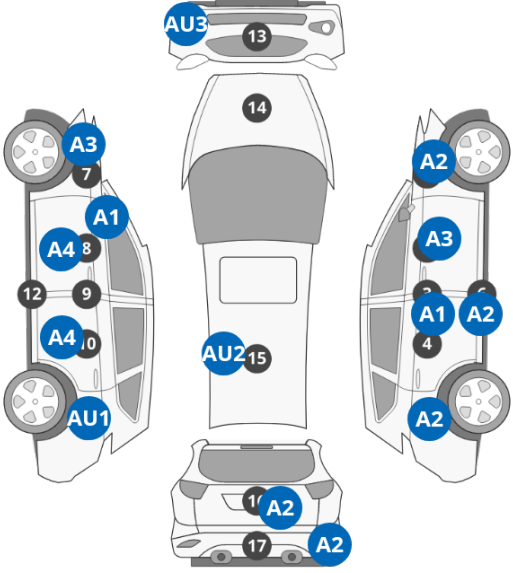
<p><b>A</b> : Scratch <b>AU</b> : Scratch &amp; Dent <b>B</b> : Modified <b>C</b> : Corrosion <b>G</b> : Stone chip <b>P</b> : Faded <b>S</b> : Rust <b>SC</b> : Rust &amp; Corrosion <b>U</b> : Dent <b>X</b> : Defective <b>Y</b> : Crack, Gap</p>
<p><b>Remarks</b> (R) Front Trim - Grime - Minimal / (R) Front Floor Mat - Grime - Small / Sunvisor, Sunglass Holder - Grime - Minimal / Ceiling - Grime - Minimal / (R) Rear Trim - Grime - Minimal / (L) Rear Trim - Grime - Minimal / Rear Seat - Grime - Medium / (L) Front Trim - Grime - Minimal / (L) Front Floor Mat - Worked - Small / Mat Other - Worked - Small</p>	<p><b>Remarks</b> (L) Front Fender, Molding - Scratch - Medium / (L) Front Door, Molding - Scratch - Large / (L) Mirror - Scratch - Minimal / (L) Rear Door, Molding - Scratch - Large / (L) Rear Fender, Molding - Scratch &amp; Dent - Minimal / Trunk Hood, Rear Gate - Scratch - Small / Rear Bumper, Lamps, Panels - Scratch - Small / (R) Rear Fender, Molding - Scratch - Small / (R) Rear Door, Molding - Scratch - Minimal / (R) Front Door, Molding - Scratch - Medium / (R) Step, In-panel, Side Spoiler - Scratch - Small / (R) Front Fender, Molding - Scratch - Small / Front Bumper, Grille, Lamps - Scratch &amp; Dent - Medium / Roof - Scratch &amp; Dent - Small</p>
