## General Information

<b>Make</b>	Honda	<b>Model</b>	City
<b>YOM</b>	2016	<b>Odo Meter Reading</b>	57,324
<b>Registration No.</b>	ABI6117	<b>Chassis No.</b>	PADGM6630GV206296
<b>CC</b>	1.5	<b>Transmission</b>	A/T
<b>Fuel Type</b>	Gas	<b>Type of Body</b>	Sedan
<b>Colour</b>	Gray

## Body / Panel Condition

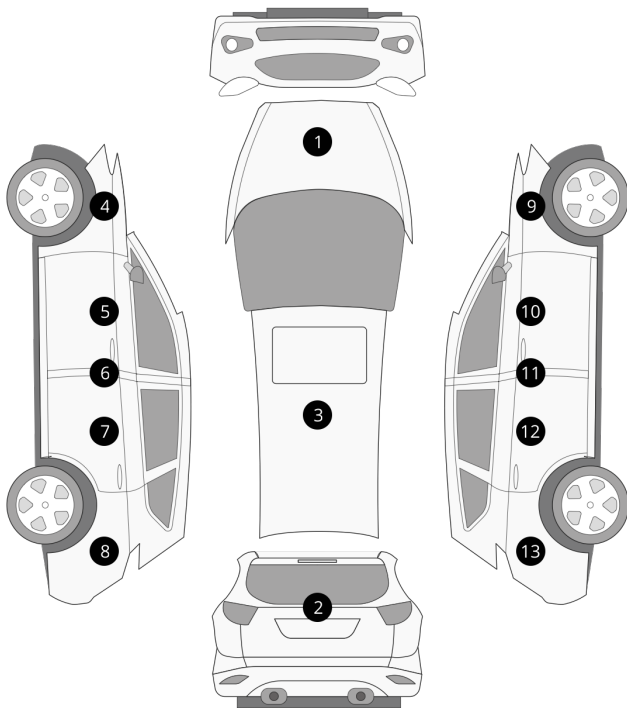
#	Area	Thickness(um)			
		Average	Value1	Value2	Value3/4
1	Bonnet	90.0	93	97	79
2	Boot Lid	103.4	114	85	111
3	Roof	94.7	88	107	88/96
4	Left Front Fender	169.0	267	127	113
5	Left Front Door	107.7	129	95	99
6	Center Panel Left				
7	Left Rear Door	100.2	98	96	106
8	Left Back Panel	108.0	104	111	109
9	Right Front Fender	118.6	121	118	117
10	Right Front Door	444.0	892	310	130
11	Center Panel Right				
12	Right Rear Door	415.0	134	146	965
13	Right Back Panel	129.0	123	132	132

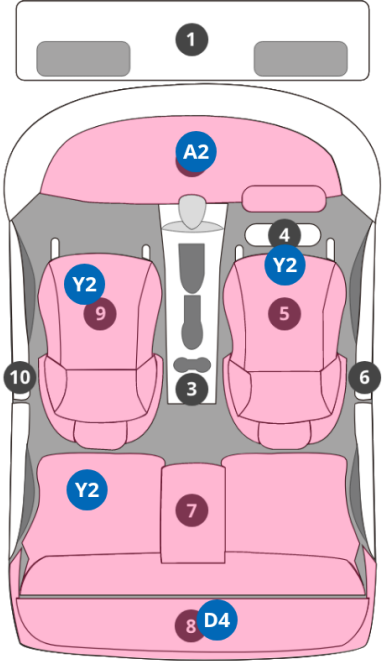
<b>Interior Evaluation :</b> <span style="float: right; color: red; font-weight: bold;">C</span>	<b>Exterior Evaluation :</b> <span style="float: right; color: red; font-weight: bold;">E</span>

<p><b>a</b> : Cut, Fray <b>d</b> : Loose, Deformed <b>k</b> : Animal Hair <b>s</b> : Smell <b>t</b> : Cigarette Burns <b>x</b> : Defective <b>y</b> : Stain</p>

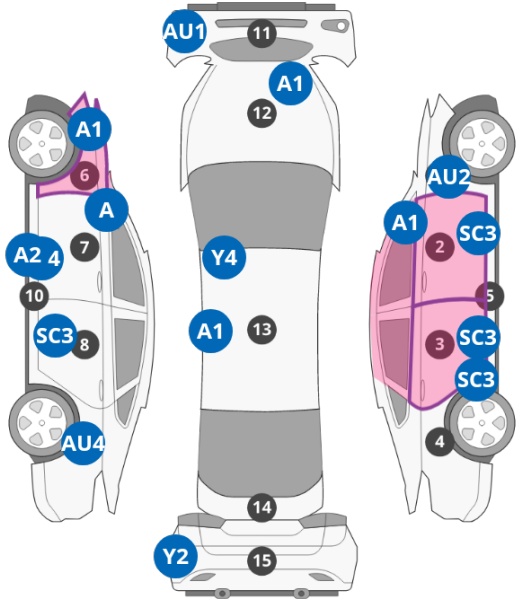
<p><b>A</b> : Scratch <b>AU</b> : Scratch &amp; Dent <b>B</b> : Modified <b>C</b> : Corrosion <b>G</b> : Stone chip <b>P</b> : Faded <b>S</b> : Rust <b>SC</b> : Rust &amp; Corrosion <b>U</b> : Dent <b>X</b> : Defective <b>Y</b> : Crack, Gap</p>
<p><b>Remarks</b> (R) Front Seat - Grime - Small / Trunk Room - Loose, Deformed - Large / Rear Seat - Grime - Small / (L) Front Seat - Grime - Small / Steering Wheel - Worn, Peel, Crack - Small</p>	<p><b>Remarks</b> (R) Front Door - Repair Traces - Yes / (R) Step - Repair Traces - Yes / Bonnet - Repair Traces - Yes / (L) Front Fender - Repair Traces - Yes / (L) Front Door - Repair Traces - Yes / (L) Rear Door - Repair Traces - Yes / (L) Rear Fender - Repair Traces - Yes / Trunk Hood, Rear Gate - Repair Traces - Yes / (R) Rear Door - Repair Traces - Yes / Roof - Repair Traces - Yes / Front Windshield - Damaged - Large / Overall Exterior - Full Re-Paint in same color - Yes / (R) Mirror - Scratch, Peeled - Minimal / (R) Front Fender, Molding - Scratch &amp; Dent - Small / (R) Front Door, Molding - Repair mark - Difference in Color / (R) Rear Door, Molding - Repair mark - Difference in Color / (R) Front Door, Molding - Rust, Corrosion - Medium / (R) Rear Door, Molding - Rust, Corrosion - Medium / (R) Rear Fender, Molding - Rust, Corrosion - Medium / Trunk Hood, Rear Gate - Crack, Gap - Small / (L) Rear Fender, Molding - Scratch &amp; Dent - Large / (L) Rear Door, Molding - Rust, Corrosion - Medium / (L) Front Door, Molding - Rust, Corrosion - Large / (L) Step, In-panel, Side Spoiler - Scratch - Small / (L) Mirror - Scratch, Peeled - Yes / (L) Front Fender, Molding - Repair mark - Yes / (L) Front Fender, Molding - Scratch - Minimal / Front Bumper, Grille, Lamps - Scratch &amp; Dent - Minimal / Bonnet, Headlight - Scratch - Minimal / Roof - Scratch - Minimal</p>
