General Information

| Make | Toyota | Model | Vios |
| Registration No. | NIF4307 | Chassis No. | PA1B18F3XN4195454 |

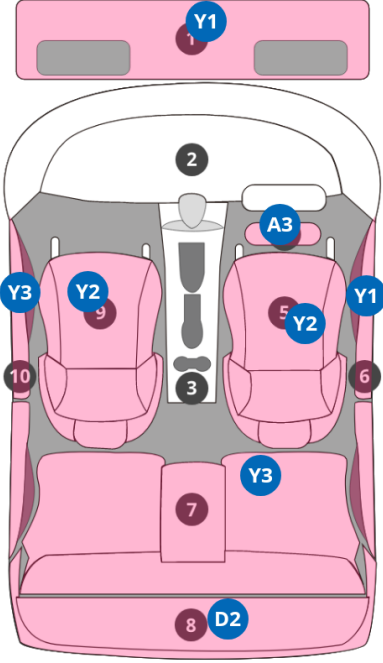
| Remarks Ceiling - Grime - Minimal / Rear Seat - Grime - Medium / (R) Front Floor Mat - Cut, Crack - Medium / (L) Front Seat - Grime - Small / (R) Front Seat - Grime - Small / (L) Front Trim - Grime - Medium / (R) Front Trim - Grime - Minimal / Trunk Room - Loose, Deformed - Small | Remarks Roof - Scratch - Small / (L) Front Fender, Molding - Scratch - Small / (L) Front Door, Molding - Scratch & Dent - Small / (L) Rear Door, Molding - Scratch & Dent - Small / (L) Step, In-panel, Side Spoiler - Scratch & Dent - Small / (L) Rear Fender, Molding - Scratch & Dent - Medium / Rear Bumper, Lamps, Panels - Scratch & Dent - Medium / Trunk Hood, Rear Gate - Scratch & Dent - Small / (R) Rear Fender, Molding - Scratch & Dent - Medium / (R) Rear Door, Molding - Scratch - Medium / (R) Front Door, Molding - Scratch & Dent - Small / (R) Step, In-panel, Side Spoiler - Scratch - Small / (R) Front Fender, Molding - Scratch & Dent - Small / Bonnet, Headlight - Scratch & Dent - Minimal / Front Bumper, Grille, Lamps - Scratch & Dent - Small |

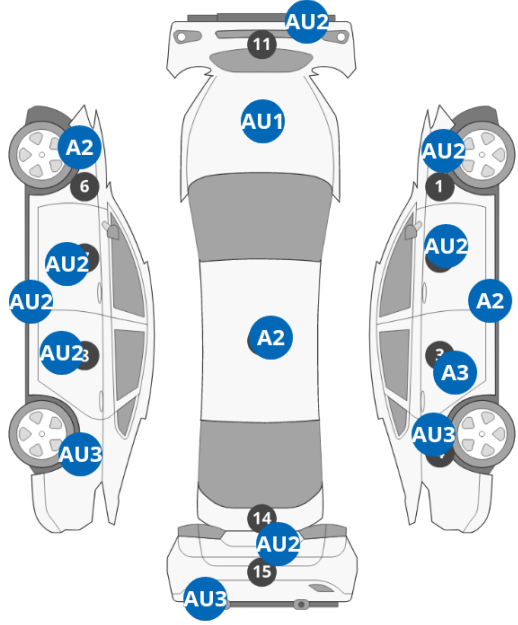
| with LTO plate, with spare tire, with spare key, with jack, no warranty and manual booklet, scratches on taillight and headlight. |
