## General Information

<b>Make</b>	Toyota	<b>Model</b>	Vios
<b>YOM</b>	2024	<b>Odo Meter Reading</b>	26,434
<b>Registration No.</b>	NKC8397	<b>Chassis No.</b>	PA1B18F38R4254605
<b>CC</b>	1.3	<b>Transmission</b>	CVT
<b>Fuel Type</b>	Gas	<b>Type of Body</b>	Sedan
<b>Colour</b>	Black

## Body / Panel Condition

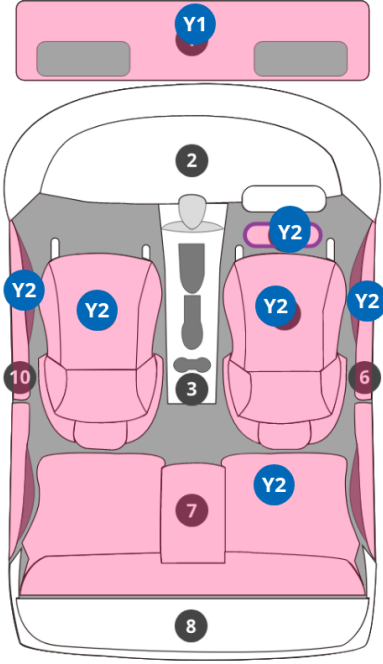
<b>Interior Evaluation :</b> <span style="float: right;"><b>B</b></span>	<b>Exterior Evaluation :</b> <span style="float: right;"><b>E</b></span>

<p><b>a</b> : Cut, Fray <b>d</b> : Loose, Deformed <b>k</b> : Animal Hair <b>s</b> : Smell <b>t</b> : Cigarette Burns <b>x</b> : Defective <b>y</b> : Stain</p>

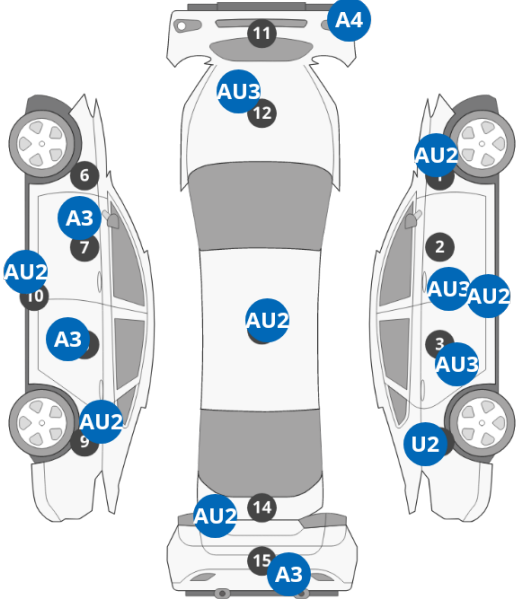
<p><b>A</b> : Scratch <b>AU</b> : Scratch &amp; Dent <b>B</b> : Modified <b>C</b> : Corrosion <b>G</b> : Stone chip <b>P</b> : Faded <b>S</b> : Rust <b>SC</b> : Rust &amp; Corrosion <b>U</b> : Dent <b>X</b> : Defective <b>Y</b> : Crack, Gap</p>
<p><b>Remarks</b> (L) Front Floor Mat - Missing - Yes / (R) Front Floor Mat - Grime - Small / (L) Front Trim - Grime - Small / (R) Front Trim - Grime - Small / Rear Seat - Grime - Small / (R) Front Seat - Grime - Small / (L) Front Seat - Grime - Small / Ceiling - Grime - Minimal</p>	<p><b>Remarks</b> (L) Front Door, Molding - Scratch - Medium / (L) Step, In-panel, Side Spoiler - Scratch &amp; Dent - Small / (L) Rear Door, Molding - Scratch - Medium / (L) Rear Fender, Molding - Scratch &amp; Dent - Small / Trunk Hood, Rear Gate - Scratch &amp; Dent - Small / Rear Bumper, Lamps, Panels - Scratch - Medium / (R) Rear Fender, Molding - Dent - Small / (R) Rear Door, Molding - Scratch &amp; Dent - Medium / (R) Front Door, Molding - Scratch &amp; Dent - Medium / (R) Step, In-panel, Side Spoiler - Scratch &amp; Dent - Small / Roof - Scratch &amp; Dent - Small / Front Bumper, Grille, Lamps - Scratch - Large / (R) Front Fender, Molding - Scratch &amp; Dent - Small / Bonnet, Headlight - Scratch &amp; Dent - Medium</p>
