## General Information

Date & Time: 20, Jan, 2026 15:48

<b>Make</b>	Toyota	<b>Model</b>	Avanza
<b>YOM</b>	2025	<b>Odo Meter Reading</b>	10,642
<b>Registration No.</b>	NOA5027	<b>Chassis No.</b>	MHFAA1BY2S0041165
<b>CC</b>	1.3	<b>Transmission</b>	CVT
<b>Fuel Type</b>	Gas	<b>Type of Body</b>	Wagon
<b>Colour</b>	Green

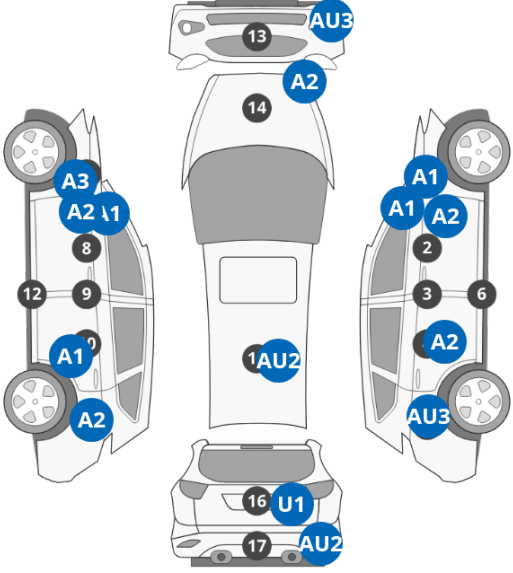
<p><b>A</b> : Scratch <b>AU</b> : Scratch &amp; Dent <b>B</b> : Modified <b>C</b> : Corrosion <b>G</b> : Stone chip <b>P</b> : Faded <b>S</b> : Rust <b>SC</b> : Rust &amp; Corrosion <b>U</b> : Dent <b>X</b> : Defective <b>Y</b> : Crack, Gap</p>
<p><b>Remarks</b> (L) Front Seat - Grime - Small / (R) Front Seat - Grime - Medium / Rear Seat - Grime - Medium / Ceiling - Crinkle - Medium / (L) Front Floor Mat - Worked - Small / (R) Front Floor Mat - Grime - Small</p>	<p><b>Remarks</b> (R) Mirror - Scratch - Minimal / (R) Front Door, Molding - Scratch - Small / (R) Rear Door, Molding - Scratch - Small / (R) Front Fender, Molding - Scratch - Minimal / (R) Rear Fender, Molding - Scratch &amp; Dent - Medium / Rear Bumper, Lamps, Panels - Scratch &amp; Dent - Small / Trunk Hood, Rear Gate - Dent - Minimal / (L) Rear Fender, Molding - Scratch - Small / (L) Mirror - Scratch - Minimal / (L) Front Fender, Molding - Scratch - Medium / (L) Rear Door, Molding - Scratch - Minimal / (L) Front Door, Molding - Scratch - Small / Front Bumper, Grille, Lamps - Scratch &amp; Dent - Medium / Bonnet, Headlight - Scratch - Small / Roof - Scratch &amp; Dent - Small</p>
