## General Information

<b>Make</b>	Toyota	<b>Model</b>	Vios
<b>YOM</b>	2024	<b>Odo Meter Reading</b>	20,957
<b>Registration No.</b>	DBO3995	<b>Chassis No.</b>	PA1B18F37R4239738
<b>CC</b>	1.3	<b>Transmission</b>	CVT
<b>Fuel Type</b>	Gas	<b>Type of Body</b>	Sedan
<b>Colour</b>	Silver

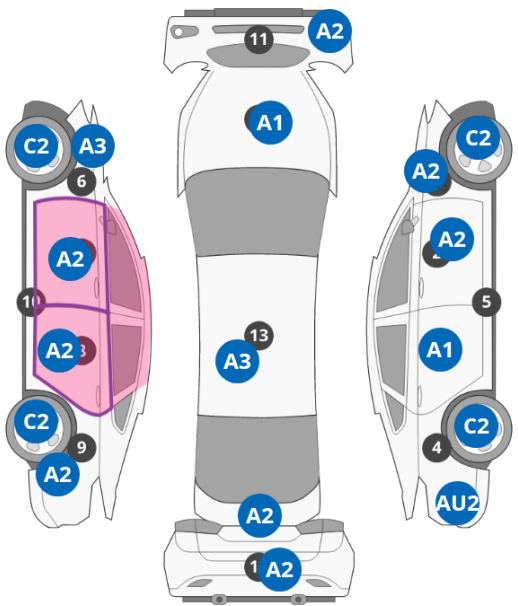
<p><b>A</b> : Scratch <b>AU</b> : Scratch &amp; Dent <b>B</b> : Modified <b>C</b> : Corrosion <b>G</b> : Stone chip <b>P</b> : Faded <b>S</b> : Rust <b>SC</b> : Rust &amp; Corrosion <b>U</b> : Dent <b>X</b> : Defective <b>Y</b> : Crack, Gap</p>
<p><b>Remarks</b> (R) Front Seat - Grime - Medium / (R) Front Trim - Grime - Small / Rear Seat - Grime - Medium / Trunk Room - Worn, Scratch, Cut, Crack - Small / (L) Front Trim - Grime - Medium / (L) Front Floor Mat - Grime - Small</p>	<p><b>Remarks</b> (L) Front Door - Repair Traces - Yes / (L) Rear Door - Repair Traces - Yes / Roof - Scratch - Medium / (L) Front Door, Molding - Repair mark - Yes / (L) Rear Door, Molding - Repair mark - Yes / (L) Rear Door, Molding - Scratch - Small / (L) Front Door, Molding - Scratch - Small / (L) Rear Fender, Molding - Scratch - Small / (L) Front Fender, Molding - Scratch - Medium / Rear Bumper, Lamps, Panels - Scratch - Small / Trunk Hood, Rear Gate - Scratch - Small / Front Bumper, Grille, Lamps - Scratch - Small / Bonnet, Headlight - Scratch - Minimal / (R) Front Fender, Molding - Scratch - Small / (R) Front Door, Molding - Scratch - Small / (R) Rear Door, Molding - Scratch - Minimal / (R) Rear Fender, Molding - Scratch &amp; Dent - Small / (L) Rear Wheel, Cover - Scratch, Corrosion - Small / (L) Front Wheel, Cover - Scratch, Corrosion - Small / (R) Front Wheel, Cover - Scratch, Corrosion - Small / (R) Rear Wheel, Cover - Scratch, Corrosion - Small</p>
