General Information

Make	Toyota	Model	Rush
YOM	2022	Odo Meter Reading	122,427
Registration No.	DAP8584	Chassis No.	MHKE8FF3PNK040603
CC	1.5	Transmission	A/T
Fuel Type	Gas	Type of Body	SUV
Colour	Red Mica Metallic

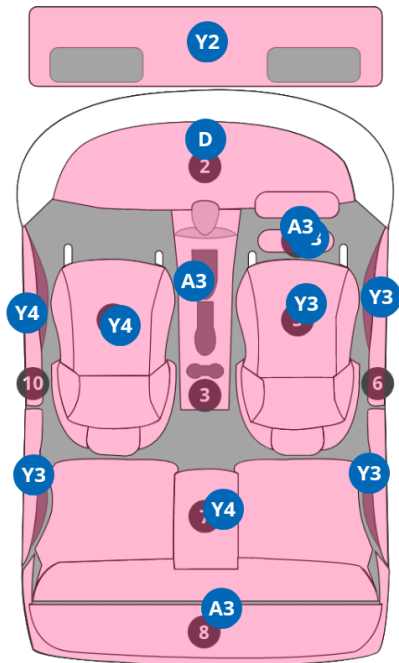
Interior Evaluation : E	Exterior Evaluation : E

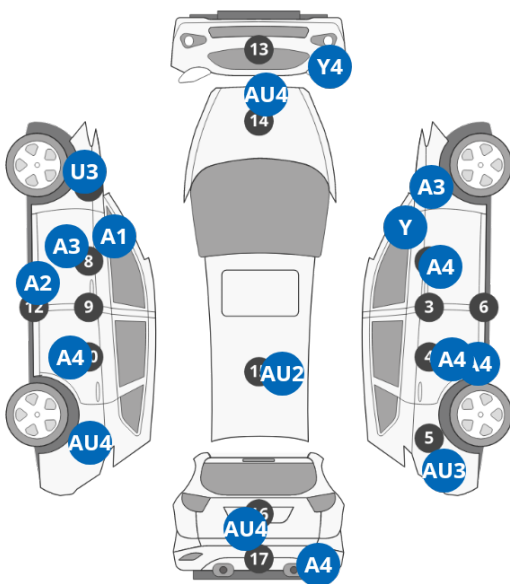
<p>A : Scratch AU : Scratch & Dent B : Modified C : Corrosion G : Stone chip P : Faded S : Rust SC : Rust & Corrosion U : Dent X : Defective Y : Crack, Gap</p>
<p>Remarks (R) Front Seat - Grime - Medium / (R) Front Trim - Grime - Medium / Rear Seat - Grime - Large / Mat Other - Crinkle - Medium / (R) Rear Trim - Grime - Medium / Trunk Room - Worn, Scratch, Cut, Crack - Medium / (L) Rear Trim - Grime - Medium / (L) Front Trim - Grime - Large / (L) Front Seat - Grime - Large / (L) Front Floor Mat - Cut, Crack - Medium / Console, Switches, Vents - Worn, Scratch, Cut, Crack - Medium / Dashboard - Traces of Adhesive Tape - Yes / Ceiling - Grime - Small</p>	<p>Remarks (R) Front Fender - Repair Traces - Yes / Bonnet - Repair Traces - Yes / (L) Front Fender - Repair Traces - Yes / Bonnet, Headlight - Scratch & Dent - Large / Front Bumper, Grille, Lamps - Crack, Gap - Large / (R) Front Fender, Molding - Scratch - Medium / (R) Mirror - Crack - Damaged / (R) Front Door, Molding - Scratch - Large / (R) Step, In-panel, Side Spoiler - Scratch - Large / (R) Rear Door, Molding - Scratch - Large / (R) Rear Fender, Molding - Scratch & Dent - Medium / Trunk Hood, Rear Gate - Scratch & Dent - Large / Rear Bumper, Lamps, Panels - Scratch - Large / (L) Rear Fender, Molding - Scratch & Dent - Large / (L) Rear Door, Molding - Scratch - Large / (L) Front Door, Molding - Scratch - Medium / (L) Step, In-panel, Side Spoiler - Scratch - Small / (L) Mirror - Scratch - Minimal / (L) Front Fender, Molding - Dent - Medium / Roof - Scratch & Dent - Small</p>
