## General Information

**Date & Time: 21, Jan, 2026 15:09**

<b>Make</b>	Toyota	<b>Model</b>	Hiace
<b>YOM</b>	2021	<b>Odo Meter Reading</b>	77,407
<b>Registration No.</b>	DAU7318	<b>Chassis No.</b>	JTFJT02P5M0014852
<b>CC</b>	3.0	<b>Transmission</b>	M/T
<b>Fuel Type</b>	Diesel	<b>Type of Body</b>	Van
<b>Colour</b>	Silver

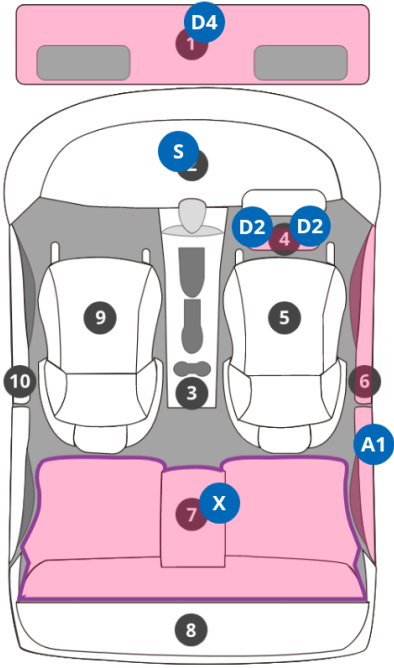
<b>Interior Evaluation :</b> <span style="color: red; font-weight: bold; font-size: 1.2em;">C</span>	<b>Exterior Evaluation :</b> <span style="color: red; font-weight: bold; font-size: 1.2em;">E</span>

<p><b>a</b> : Cut, Fray <b>d</b> : Loose, Deformed <b>k</b> : Animal Hair <b>s</b> : Smell <b>t</b> : Cigarette Burns <b>x</b> : Defective <b>y</b> : Stain</p>

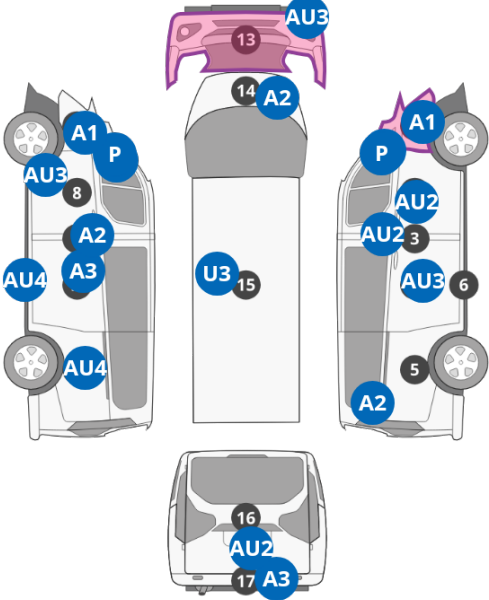
<p><b>A</b> : Scratch <b>AU</b> : Scratch &amp; Dent <b>B</b> : Modified <b>C</b> : Corrosion <b>G</b> : Stone chip <b>P</b> : Faded <b>S</b> : Rust <b>SC</b> : Rust &amp; Corrosion <b>U</b> : Dent <b>X</b> : Defective <b>Y</b> : Crack, Gap</p>
<p><b>Remarks</b> Overall Interior - Worn as per age - Yes / Overall Interior - Smell - Yes / Rear Seat - Missing - Yes / Ceiling - Crinkle - Large / (R) Rear Trim - Cut, Crack - Minimal / (L) Front Floor Mat - Worked - Small / (R) Front Floor Mat - Worked - Small</p>	<p><b>Remarks</b> (R) Rear Fender - Repair Traces - Yes / (R) Rear Door - Repair Traces - Yes / (R) Center Panel - Repair Traces - Yes / Overall Exterior - Full Re-Paint in same color - Yes / Front Bumper, Grille, Lamps - Repair mark - Yes / (R) Front Fender, Molding - Repair mark - Yes / (R) Front Fender, Molding - Scratch - Minimal / (R) Mirror - Scratch - Small / (R) Mirror - Faded(Color, Gloss) - Yes / (R) Front Door, Molding - Scratch &amp; Dent - Small / (R) Center Panel - Scratch &amp; Dent - Small / (R) Rear Door, Molding - Scratch &amp; Dent - Medium / (R) Rear Fender, Molding - Scratch - Small / Rear Bumper, Lamps, Panels - Scratch - Medium / Trunk Hood, Rear Gate - Scratch &amp; Dent - Small / (L) Rear Fender, Molding - Scratch &amp; Dent - Large / (L) Step, In-panel, Side Spoiler - Scratch &amp; Dent - Large / (L) Rear Door, Molding - Scratch - Medium / (L) Center Panel - Scratch - Small / (L) Mirror - Scratch - Small / (L) Mirror - Faded(Color, Gloss) - Yes / (L) Front Door, Molding - Scratch &amp; Dent - Medium / (L) Front Fender, Molding - Scratch - Minimal / Front Bumper, Grille, Lamps - Scratch &amp; Dent - Medium / Front Panel - Scratch - Small / Roof - Dent - Medium</p>
