## General Information

<b>Make</b>	Toyota	<b>Model</b>	Wigo
<b>YOM</b>	2023	<b>Odo Meter Reading</b>	57,473
<b>Registration No.</b>	DBG1056	<b>Chassis No.</b>	MHKA4DF5FNJ075692
<b>CC</b>	1.0	<b>Transmission</b>	A/T
<b>Fuel Type</b>	Gas	<b>Type of Body</b>	Hatchback
<b>Colour</b>	Black

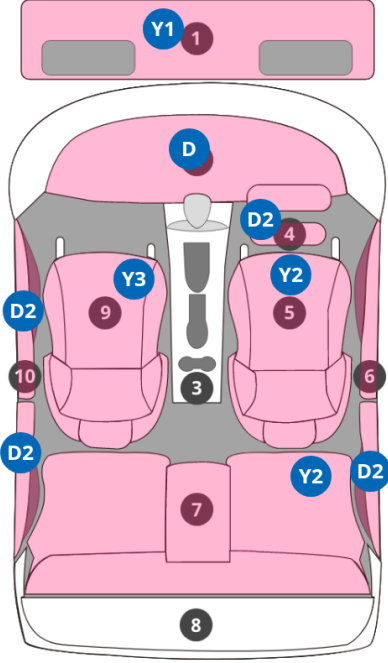
<b>Interior Evaluation :</b> <span style="float: right; color: red; font-weight: bold;">C</span>	<b>Exterior Evaluation :</b> <span style="float: right; color: red; font-weight: bold;">E</span>

<p><b>a</b> : Cut, Fray <b>d</b> : Loose, Deformed <b>k</b> : Animal Hair <b>s</b> : Smell <b>t</b> : Cigarette Burns <b>x</b> : Defective <b>y</b> : Stain</p>

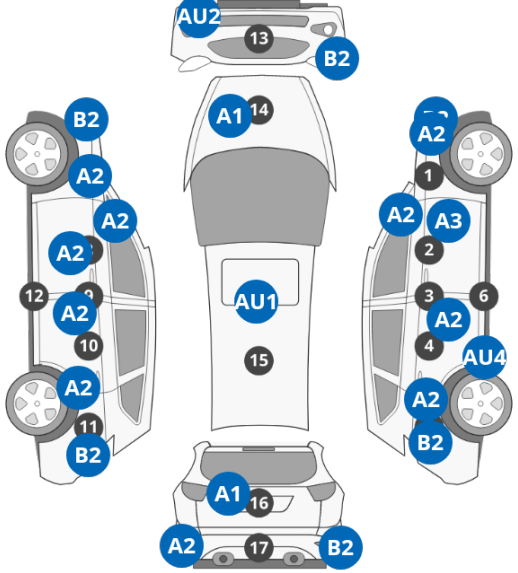
<p><b>A</b> : Scratch <b>AU</b> : Scratch &amp; Dent <b>B</b> : Modified <b>C</b> : Corrosion <b>G</b> : Stone chip <b>P</b> : Faded <b>S</b> : Rust <b>SC</b> : Rust &amp; Corrosion <b>U</b> : Dent <b>X</b> : Defective <b>Y</b> : Crack, Gap</p>
<p><b>Remarks</b> (R) Front Seat - Grime - Small / (L) Front Seat - Grime - Medium / (L) Front Floor Mat - Worked - Small / (R) Rear Trim - Worked - Small / (L) Rear Trim - Worked - Small / (L) Front Trim - Worked - Small / Rear Seat - Grime - Small / Dashboard - Traces of Adhesive Tape - Yes / Ceiling - Grime - Minimal</p>	<p><b>Remarks</b> (R) Mirror - Scratch - Small / (R) Front Door, Molding - Scratch - Medium / (R) Step, In-panel, Side Spoiler - Scratch &amp; Dent - Large / (R) Front Fender, Molding - Modified - Small / (R) Front Fender, Molding - Scratch - Small / Front Bumper, Grille, Lamps - Modified - Small / (R) Rear Door, Molding - Scratch - Small / (R) Rear Fender, Molding - Modified - Small / Rear Bumper, Lamps, Panels - Modified - Small / (L) Rear Fender, Molding - Modified - Small / (R) Rear Fender, Molding - Scratch - Small / Rear Bumper, Lamps, Panels - Scratch - Small / Trunk Hood, Rear Gate - Scratch - Minimal / (L) Rear Fender, Molding - Scratch - Small / (L) Front Fender, Molding - Modified - Small / (L) Front Door, Molding - Scratch - Small / (L) Rear Door, Molding - Scratch - Small / (L) Mirror - Scratch - Small / (L) Front Fender, Molding - Scratch - Small / Front Bumper, Grille, Lamps - Scratch &amp; Dent - Small / Bonnet, Headlight - Scratch - Minimal / Roof - Scratch &amp; Dent - Minimal</p>
