## General Information

<b>Make</b>	Toyota	<b>Model</b>	Vios
<b>YOM</b>	2021	<b>Odo Meter Reading</b>	46,249
<b>Registration No.</b>	EAE4260	<b>Chassis No.</b>	PA1B18F31M4155276
<b>CC</b>	1.3	<b>Transmission</b>	CVT
<b>Fuel Type</b>	Gas	<b>Type of Body</b>	Sedan
<b>Colour</b>	Black

## Body / Panel Condition

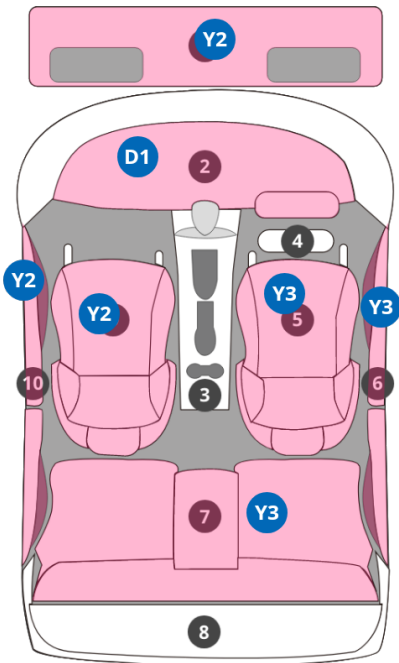
<b>Interior Evaluation :</b> <span style="float: right; color: red; font-weight: bold;">C</span>	<b>Exterior Evaluation :</b> <span style="float: right; color: red; font-weight: bold;">D</span>

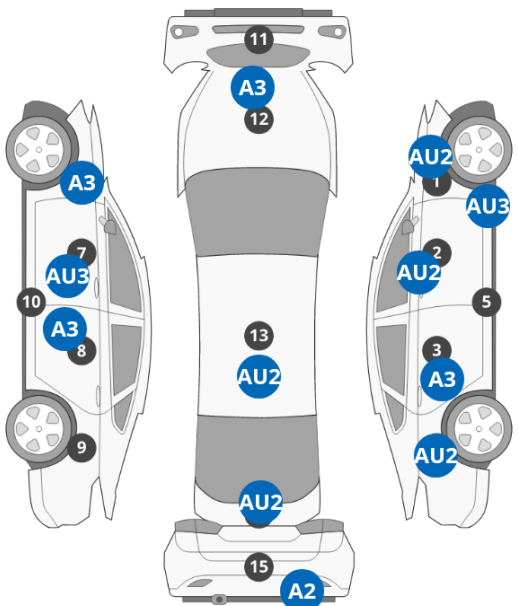
<p><b>A</b> : Scratch <b>AU</b> : Scratch &amp; Dent <b>B</b> : Modified <b>C</b> : Corrosion <b>G</b> : Stone chip <b>P</b> : Faded <b>S</b> : Rust <b>SC</b> : Rust &amp; Corrosion <b>U</b> : Dent <b>X</b> : Defective <b>Y</b> : Crack, Gap</p>
<p><b>Remarks</b> (R) Front Seat - Grime - Medium / Rear Seat - Grime - Medium / (L) Front Seat - Grime - Small / Dashboard - Worked - Minimal / (L) Front Trim - Grime - Small / (R) Front Trim - Grime - Medium / Ceiling - Grime - Small</p>	<p><b>Remarks</b> Trunk Hood, Rear Gate - Scratch &amp; Dent - Small / (R) Rear Fender, Molding - Scratch &amp; Dent - Small / Roof - Scratch &amp; Dent - Small / (R) Rear Door, Molding - Scratch - Medium / (R) Front Door, Molding - Scratch &amp; Dent - Small / (R) Step, In-panel, Side Spoiler - Scratch &amp; Dent - Medium / (R) Front Fender, Molding - Scratch &amp; Dent - Small / Bonnet, Headlight - Scratch - Medium / (L) Front Fender, Molding - Scratch - Medium / (L) Rear Door, Molding - Scratch - Medium / (L) Front Door, Molding - Scratch &amp; Dent - Medium / Rear Bumper, Lamps, Panels - Scratch - Small</p>
