General Information

Make	Toyota	Model	Vios
YOM	2022	Odo Meter Reading	175,192
Registration No.	NHB5980	Chassis No.	PA1B18F32N4190698
CC	1.3	Transmission	CVT
Fuel Type	Gas	Type of Body	Sedan
Colour	Red Mica Metallic

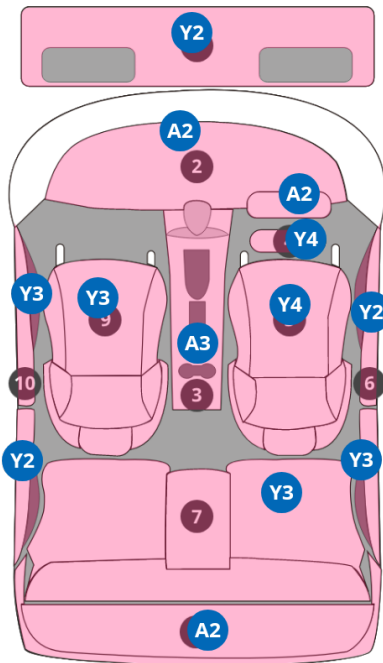
Interior Evaluation : E	Exterior Evaluation : E

<p>a : Cut, Fray d : Loose, Deformed k : Animal Hair s : Smell t : Cigarette Burns x : Defective y : Stain</p>

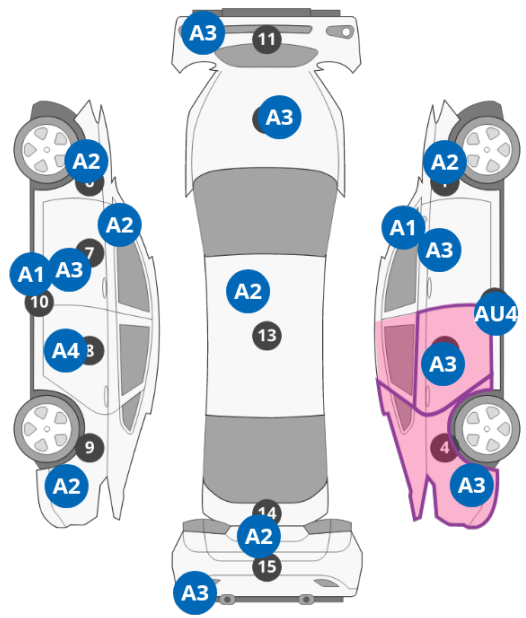
<p>A : Scratch AU : Scratch & Dent B : Modified C : Corrosion G : Stone chip P : Faded S : Rust SC : Rust & Corrosion U : Dent X : Defective Y : Crack, Gap</p>
<p>Remarks (R) Front Seat - Grime - Large / (R) Front Trim - Grime - Small / Rear Seat - Grime - Medium / (R) Rear Trim - Grime - Medium / Trunk Room - Worn, Scratch, Cut, Crack - Small / (L) Rear Trim - Grime - Small / (L) Front Trim - Grime - Medium / (L) Front Seat - Grime - Medium / (L) Front Floor Mat - Grime - Large / Steering Wheel - Worn, Peel, Crack - Small / Console, Switches, Vents - Worn, Scratch, Cut, Crack - Medium / Ceiling - Grime - Small / Dashboard - Worn, Scratch, Cut, Crack - Small</p>	<p>Remarks (L) Front Fender - Repair Traces - Yes / (R) Rear Fender - Repair Traces - Yes / (R) Rear Door - Repair Traces - Yes / Roof - Repair Traces - Yes / (R) Mirror - Scratch - Minimal / Bonnet, Headlight - Scratch - Medium / (R) Rear Door, Molding - Repair mark - Yes / (R) Rear Fender, Molding - Repair mark - Yes / Front Bumper, Grille, Lamps - Scratch - Medium / (L) Mirror - Scratch - Small / (L) Front Fender, Molding - Scratch - Small / (L) Step, In-panel, Side Spoiler - Scratch - Minimal / (L) Rear Door, Molding - Scratch - Large / (L) Front Door, Molding - Scratch - Medium / (L) Rear Fender, Molding - Scratch - Small / Trunk Hood, Rear Gate - Scratch - Small / Rear Bumper, Lamps, Panels - Scratch - Medium / (R) Rear Fender, Molding - Scratch - Medium / (R) Rear Door, Molding - Scratch - Medium / (R) Front Door, Molding - Scratch - Medium / (R) Step, In-panel, Side Spoiler - Scratch & Dent - Large / (R) Front Fender, Molding - Scratch - Small / Roof - Scratch - Small</p>
