## General Information

<b>Make</b>	Toyota	<b>Model</b>	Raize
<b>YOM</b>	2023	<b>Odo Meter Reading</b>	40,197
<b>Registration No.</b>	NIL3809	<b>Chassis No.</b>	MHKAB1BA7PJ039611
<b>CC</b>	1.2	<b>Transmission</b>	CVT
<b>Fuel Type</b>	Gas	<b>Type of Body</b>	SUV
<b>Colour</b>	Gray

## Body / Panel Condition

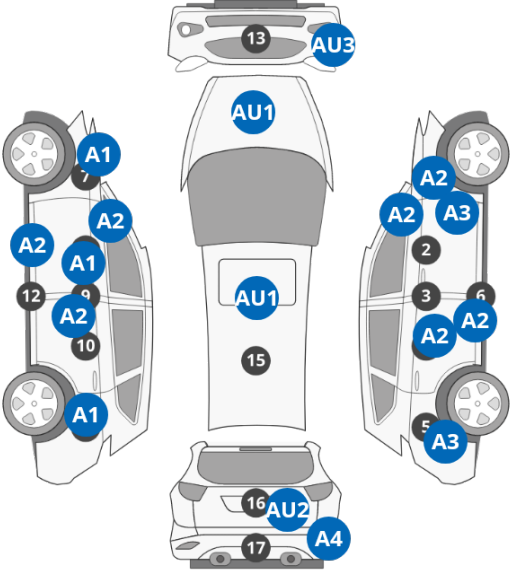
<p><b>A</b> : Scratch <b>AU</b> : Scratch &amp; Dent <b>B</b> : Modified <b>C</b> : Corrosion <b>G</b> : Stone chip <b>P</b> : Faded <b>S</b> : Rust <b>SC</b> : Rust &amp; Corrosion <b>U</b> : Dent <b>X</b> : Defective <b>Y</b> : Crack, Gap</p>
<p><b>Remarks</b> Ceiling - Grime - Small / Mat Other - Missing - Yes / (R) Front Floor Mat - Missing - Yes / (L) Front Floor Mat - Missing - Yes / (R) Front Seat - Grime - Medium / (L) Front Seat - Worn - Yes / Rear Seat - Grime - Medium</p>	<p><b>Remarks</b> (R) Mirror - Scratch - Small / (R) Front Fender, Molding - Scratch - Small / (R) Step, In-panel, Side Spoiler - Scratch - Small / (R) Front Door, Molding - Scratch - Medium / (R) Rear Door, Molding - Scratch - Small / (R) Rear Fender, Molding - Scratch - Medium / Rear Bumper, Lamps, Panels - Scratch - Large / Trunk Hood, Rear Gate - Scratch &amp; Dent - Small / (L) Rear Fender, Molding - Scratch - Minimal / (L) Step, In-panel, Side Spoiler - Scratch - Small / (L) Rear Door, Molding - Scratch - Small / (L) Front Door, Molding - Scratch - Minimal / (L) Mirror - Scratch - Small / (L) Front Fender, Molding - Scratch - Minimal / Front Bumper, Grille, Lamps - Scratch &amp; Dent - Medium / Bonnet, Headlight - Scratch &amp; Dent - Minimal / Roof - Scratch &amp; Dent - Minimal</p>
