General Information

| Make | Toyota | Model | Avanza |
| Registration No. | NKC6692 | Chassis No. | MHFAB1BY0R3099354 |

Body / Panel Condition

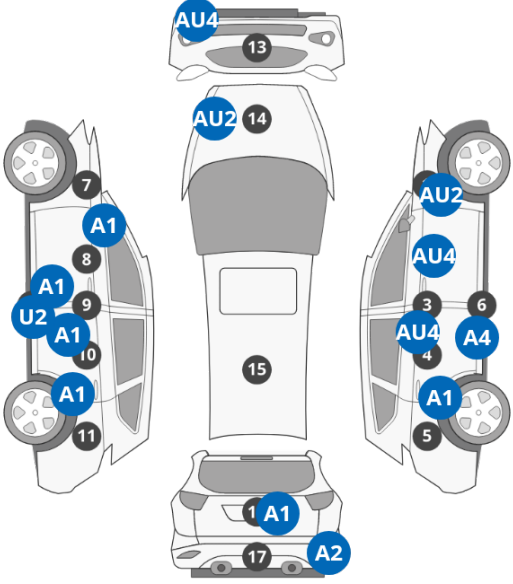
| Interior Evaluation : A | Exterior Evaluation : D |
| Remarks Defects not found | Remarks (R) Front Fender, Molding - Scratch & Dent - Small / (R) Front Door, Molding - Scratch & Dent - Large / (R) Step, In-panel, Side Spoiler - Scratch - Large / (R) Rear Door, Molding - Scratch & Dent - Large / (R) Rear Fender, Molding - Scratch - Minimal / Rear Bumper, Lamps, Panels - Scratch - Small / Trunk Hood, Rear Gate - Scratch - Minimal / (L) Rear Fender, Molding - Scratch - Minimal / (L) Rear Door, Molding - Scratch - Minimal / (L) Step, In-panel, Side Spoiler - Dent - Small / (L) Front Door, Molding - Scratch - Minimal / Front Bumper, Grille, Lamps - Scratch & Dent - Large / Bonnet, Headlight - Scratch & Dent - Small / (L) Mirror - Scratch - Minimal |
