## General Information

<b>Make</b>	Toyota	<b>Model</b>	Rush
<b>YOM</b>	2022	<b>Odo Meter Reading</b>	56,468
<b>Registration No.</b>	NER2306	<b>Chassis No.</b>	MHKE8FF3MK038814
<b>CC</b>	1.5	<b>Transmission</b>	A/T
<b>Fuel Type</b>	Gas	<b>Type of Body</b>	Wagon
<b>Colour</b>	Silver

## Body / Panel Condition

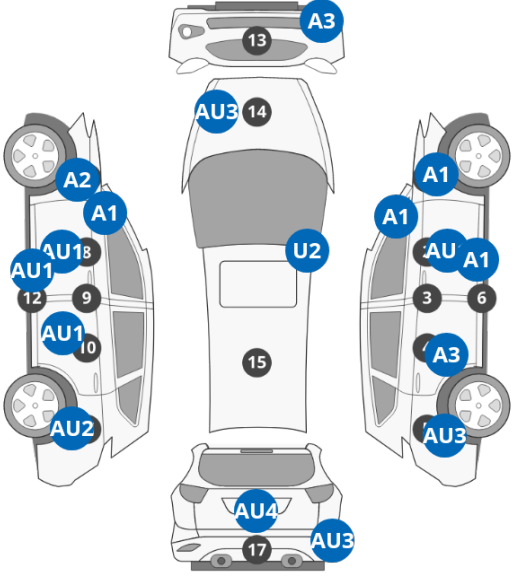
<p><b>A</b> : Scratch <b>AU</b> : Scratch &amp; Dent <b>B</b> : Modified <b>C</b> : Corrosion <b>G</b> : Stone chip <b>P</b> : Faded <b>S</b> : Rust <b>SC</b> : Rust &amp; Corrosion <b>U</b> : Dent <b>X</b> : Defective <b>Y</b> : Crack, Gap</p>
<b>Remarks</b> Rear Seat - Grime - Small / Mat Other - Missing - Yes / Steering Wheel - Worn, Peel, Crack - Medium	<b>Remarks</b> (R) Front Fender, Molding - Scratch - Minimal / (R) Mirror - Scratch - Minimal / Roof - Dent - Small / (R) Front Door, Molding - Scratch & Dent - Minimal / (R) Rear Door, Molding - Scratch - Medium / (R) Step, In-panel, Side Spoiler - Scratch - Minimal / (R) Rear Fender, Molding - Scratch & Dent - Medium / Trunk Hood, Rear Gate - Scratch & Dent - Large / Rear Bumper, Lamps, Panels - Scratch & Dent - Medium / (L) Rear Fender, Molding - Scratch & Dent - Small / (L) Rear Door, Molding - Scratch & Dent - Minimal / (L) Mirror - Scratch - Minimal / (L) Front Door, Molding - Scratch & Dent - Minimal / (L) Step, In-panel, Side Spoiler - Scratch & Dent - Minimal / (L) Front Fender, Molding - Scratch - Small / Bonnet, Headlight - Scratch & Dent - Medium / Front Bumper, Grille, Lamps - Scratch - Medium

<b>Inspector Notes</b>
With Lto plate, with warranty booklet, with spare tire and jack, 2keys, no tools, scratches on headlights and taillights,
