## General Information

Date & Time: 22, Jan, 2026 10:49

<b>Make</b>	Toyota	<b>Model</b>	Vios
<b>YOM</b>	2024	<b>Odo Meter Reading</b>	24,814
<b>Registration No.</b>	CCC3670	<b>Chassis No.</b>	PA1B18F32P4237215
<b>CC</b>	1.3	<b>Transmission</b>	CVT
<b>Fuel Type</b>	Gas	<b>Type of Body</b>	Sedan
<b>Colour</b>	Blue

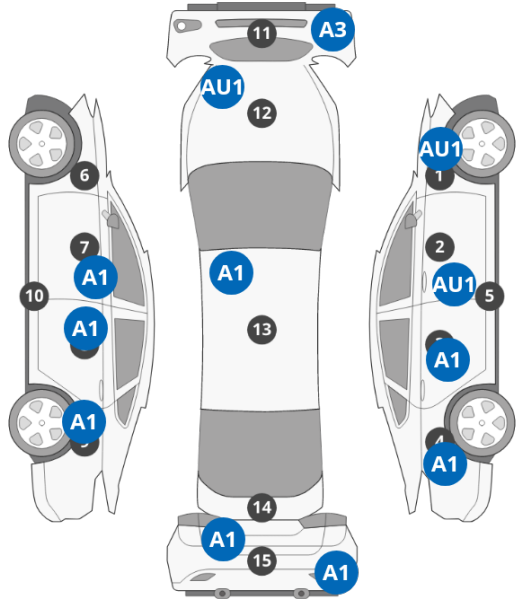
<p><b>A</b> : Scratch <b>AU</b> : Scratch &amp; Dent <b>B</b> : Modified <b>C</b> : Corrosion <b>G</b> : Stone chip <b>P</b> : Faded <b>S</b> : Rust <b>SC</b> : Rust &amp; Corrosion <b>U</b> : Dent <b>X</b> : Defective <b>Y</b> : Crack, Gap</p>
<b>Remarks</b> Defects not found	<b>Remarks</b> (R) Front Fender - Repair Traces - Yes / (R) Front Fender, Molding - Scratch & Dent - Minimal / (R) Front Door, Molding - Scratch & Dent - Minimal / (R) Rear Door, Molding - Scratch - Minimal / (R) Rear Fender, Molding - Scratch - Minimal / Trunk Hood, Rear Gate - Scratch - Minimal / Rear Bumper, Lamps, Panels - Scratch - Minimal / (L) Rear Fender, Molding - Scratch - Minimal / (L) Rear Door, Molding - Scratch - Minimal / Roof - Scratch - Minimal / (L) Front Door, Molding - Scratch - Minimal / Front Bumper, Grille, Lamps - Scratch - Medium / Bonnet, Headlight - Scratch & Dent - Minimal

<b>Inspector Notes</b>
With Lto plate, with warranty booklet, with spare tire, with jack and tools, 1key, scratches on headlights and taillights
