General Information

Make	Toyota	Model	Avanza
YOM	2019	Odo Meter Reading	78,554
Registration No.	FAH5451	Chassis No.	MHKM6EE2FJK012729
CC	1.3	Transmission	M/T
Fuel Type	Gas	Type of Body	Wagon
Colour	Gray

Body / Panel Condition

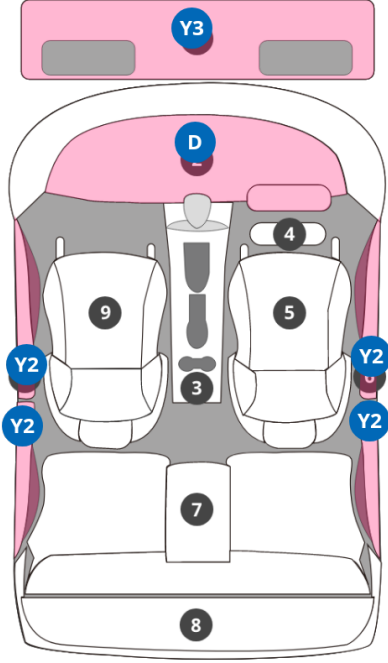
Interior Evaluation : B	Exterior Evaluation : E

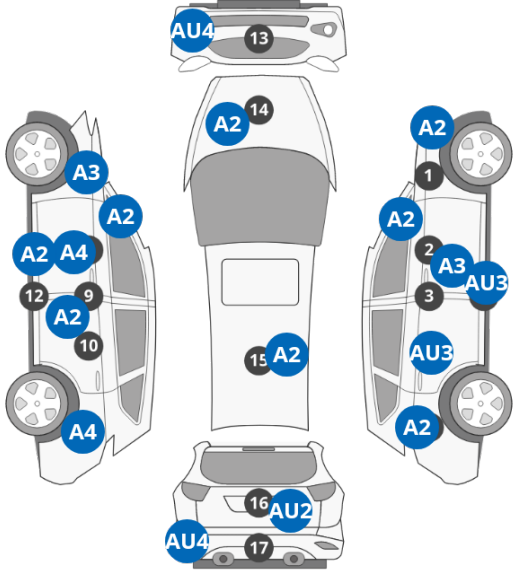
<p>A : Scratch AU : Scratch & Dent B : Modified C : Corrosion G : Stone chip P : Faded S : Rust SC : Rust & Corrosion U : Dent X : Defective Y : Crack, Gap</p>
<p>Remarks (L) Front Trim - Grime - Small / Dashboard - Traces of Adhesive Tape - Yes / (L) Rear Trim - Grime - Small / Ceiling - Grime - Medium / (R) Rear Trim - Grime - Small / (R) Front Trim - Grime - Small</p>	<p>Remarks Trunk Hood, Rear Gate - Repair Traces - Yes / Roof - Repair Traces - Yes / Overall Exterior - Faded(Color, Gloss) - Yes / (R) Rear Door, Molding - Scratch & Dent - Medium / (R) Front Door, Molding - Scratch - Medium / (R) Step, In-panel, Side Spoiler - Scratch & Dent - Medium / (R) Mirror - Scratch - Small / (R) Rear Fender, Molding - Scratch - Small / Trunk Hood, Rear Gate - Scratch & Dent - Small / (L) Rear Fender, Molding - Scratch - Large / Rear Bumper, Lamps, Panels - Scratch & Dent - Large / (L) Rear Door, Molding - Scratch - Small / (L) Front Door, Molding - Scratch - Large / (L) Mirror - Scratch - Small / (L) Step, In-panel, Side Spoiler - Scratch - Small / (L) Front Fender, Molding - Scratch - Medium / Bonnet, Headlight - Scratch - Small / Front Bumper, Grille, Lamps - Scratch & Dent - Large / (R) Front Fender, Molding - Scratch - Small / Roof - Scratch - Small</p>
