## General Information

Date & Time: 23, Jan, 2026 08:50

<b>Make</b>	Toyota	<b>Model</b>	Wigo
<b>YOM</b>	2020	<b>Odo Meter Reading</b>	51,012
<b>Registration No.</b>	FAG5852	<b>Chassis No.</b>	MHKA4DF5FKJ035099
<b>CC</b>	1.0	<b>Transmission</b>	A/T
<b>Fuel Type</b>	Gas	<b>Type of Body</b>	Hatchback
<b>Colour</b>	Red

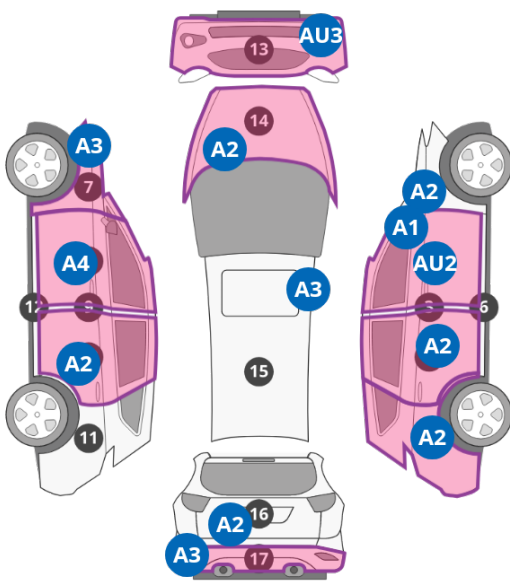
</div> <p><b>A :</b> Scratch <b>AU :</b> Scratch &amp; Dent <b>B :</b> Modified <b>C :</b> Corrosion <b>G :</b> Stone chip <b>P :</b> Faded <b>S :</b> Rust <b>SC :</b> Rust &amp; Corrosion <b>U :</b> Dent <b>X :</b> Defective <b>Y :</b> Crack, Gap</p>
<p><b>Remarks</b></p> <p>(L) Front Trim - Grime - Small / (L) Front Floor Mat - Worked - Large / Dashboard - Traces of Adhesive Tape - Yes / Console, Switchs, Vents - Traces of Adhesive Tape - Yes / Sunvisor, Sunglass Holder - Grime - Medium / Ceiling - Grime - Medium / Mat Other - Grime - Medium / Rear Seat - Grime - Medium / (L) Rear Trim - Grime - Small / (R) Rear Trim - Grime - Small / (R) Front Trim - Grime - Small / (R) Front Floor Mat - Grime - Small</p>	<p><b>Remarks</b></p> <p>(R) Front Door - Repair Traces - Yes / (R) Step - Repair Traces - Yes / (R) Front Fender - Repair Traces - Yes / Bonnet - Repair Traces - Yes / (L) Front Fender - Repair Traces - Yes / (L) Front Door - Repair Traces - Yes / (L) Step - Repair Traces - Yes / (L) Rear Door - Repair Traces - Yes / (L) Rear Fender - Repair Traces - Yes / Trunk Hood, Rear Gate - Repair Traces - Yes / (R) Rear Fender - Repair Traces - Yes / (R) Rear Door - Repair Traces - Yes / Roof - Repair Traces - Yes / (L) Front Door, Molding - Repair mark - Yes / (R) Front Door, Molding - Repair mark - Yes / (R) Rear Door, Molding - Repair mark - Yes / (L) Rear Door, Molding - Repair mark - Yes / (L) Front Fender, Molding - Repair mark - Yes / (R) Rear Fender, Molding - Repair mark - Yes / Front Bumper, Grille, Lamps - Repair mark - Yes / (L) Front Fender, Molding - Scratch - Medium / (L) Rear Door, Molding - Scratch - Small / (L) Front Door, Molding - Scratch - Large / Trunk Hood, Rear Gate - Scratch - Small / (R) Rear Fender, Molding - Scratch - Small / Rear Bumper, Lamps, Panels - Repair mark - Yes / Rear Bumper, Lamps, Panels - Scratch - Medium / (R) Rear Door, Molding - Scratch - Small / (R) Front Door, Molding - Scratch &amp; Dent - Small / (R) Front Fender, Molding - Scratch - Small / (R) Mirror - Scratch - Minimal / Bonnet, Headlight - Repair mark - Yes / Bonnet, Headlight - Scratch - Small / Front Bumper, Grille, Lamps - Scratch &amp; Dent - Medium / Roof - Scratch - Medium</p>
