## General Information

<b>Make</b>	Toyota	<b>Model</b>	Vios
<b>YOM</b>	2023	<b>Odo Meter Reading</b>	92,344
<b>Registration No.</b>	NHI7600	<b>Chassis No.</b>	PA1B18F34P4211117
<b>CC</b>	1.3	<b>Transmission</b>	CVT
<b>Fuel Type</b>	Gas	<b>Type of Body</b>	Sedan
<b>Colour</b>	Blue

## Body / Panel Condition

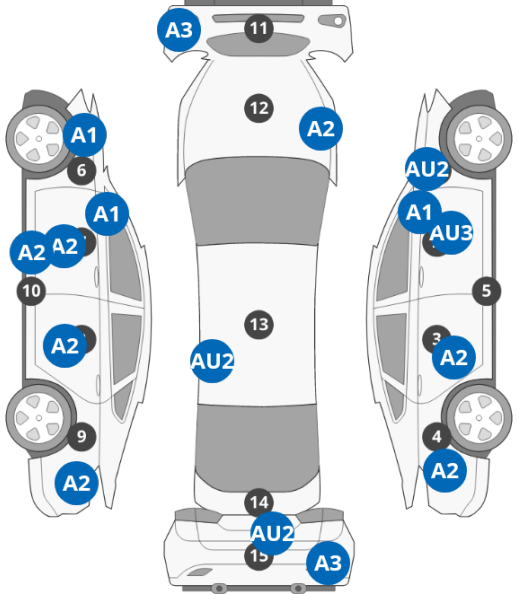
<p><b>A</b> : Scratch <b>AU</b> : Scratch &amp; Dent <b>B</b> : Modified <b>C</b> : Corrosion <b>G</b> : Stone chip <b>P</b> : Faded <b>S</b> : Rust <b>SC</b> : Rust &amp; Corrosion <b>U</b> : Dent <b>X</b> : Defective <b>Y</b> : Crack, Gap</p>
<b>Remarks</b> (R) Front Seat - Grime - Large / (R) Front Trim - Grime - Small / (L) Front Floor Mat - Missing - Yes / Rear Seat - Grime - Large / Mat Other - Missing - Yes / (R) Front Floor Mat - Missing - Yes / (R) Rear Trim - Grime - Minimal / Trunk Room - Worn, Scratch, Cut, Crack - Small / (L) Rear Trim - Grime - Small / (L) Front Trim - Grime - Medium / (L) Front Seat - Grime - Medium / Dashboard - Traces of Adhesive Tape - Yes / Ceiling - Grime - Small / Console, Switchs, Vents - Worn, Scratch, Cut, Crack - Minimal	<b>Remarks</b> (L) Mirror - Scratch - Minimal / (L) Front Fender, Molding - Scratch - Minimal / Bonnet, Headlight - Scratch - Small / (R) Front Fender, Molding - Scratch & Dent - Small / Front Bumper, Grille, Lamps - Scratch - Medium / (L) Front Door, Molding - Scratch - Small / (L) Step, In-panel, Side Spoiler - Scratch - Small / (L) Rear Door, Molding - Scratch - Small / (L) Rear Fender, Molding - Scratch - Small / Trunk Hood, Rear Gate - Scratch & Dent - Small / Rear Bumper, Lamps, Panels - Scratch - Medium / (R) Rear Fender, Molding - Scratch - Small / (R) Rear Door, Molding - Scratch - Small / (R) Front Door, Molding - Scratch & Dent - Medium / (R) Mirror - Scratch - Minimal / Roof - Scratch & Dent - Small
