General Information

Make	Toyota	Model	Avanza
YOM	2025	Odo Meter Reading	24,819
Registration No.	NJF1003 - NON-MOVING	Chassis No.	MHFAA1BY4R0031618
CC	1.3	Transmission	M/T
Fuel Type	Gas	Type of Body	MPV
Colour	Red Mica Metallic

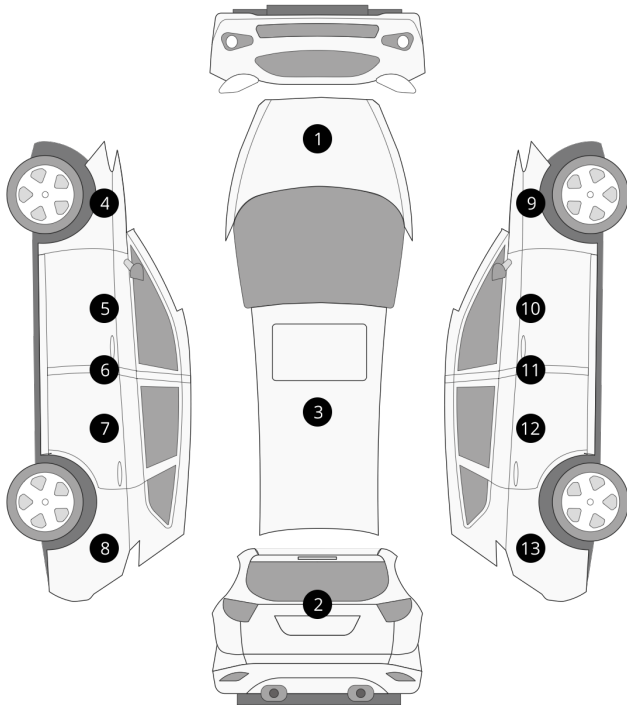
Body / Panel Condition

#	Area	Thickness(um)			
		Average	Value1	Value2	Value3/4
1	Bonnet	109.3	116	106	106
2	Boot Lid	93.8	92	102	88
3	Roof	126.0	128	128	138/110
4	Left Front Fender	102.1	102	108	97
5	Left Front Door	113.0	104	112	123
6	Center Panel Left				
7	Left Rear Door	115.6	119	107	121
8	Left Back Panel	109.3	115	104	109
9	Right Front Fender	103.2	103	109	98
10	Right Front Door	116.3	126	117	106
11	Center Panel Right				
12	Right Rear Door	112.6	118	110	110
13	Right Back Panel	116.6	130	105	115

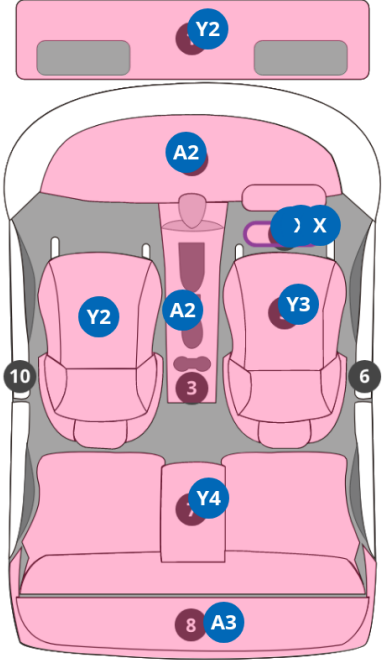
Interior Evaluation : C	Exterior Evaluation : C

<p>a : Cut, Fray d : Loose, Deformed k : Animal Hair s : Smell t : Cigarette Burns x : Defective y : Stain</p>

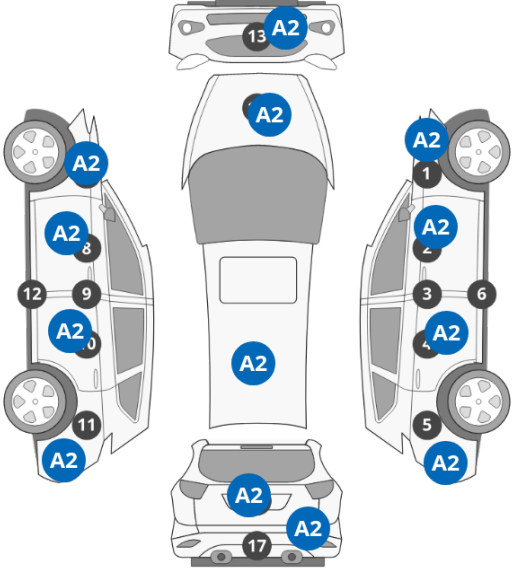
<p>A : Scratch AU : Scratch & Dent B : Modified C : Corrosion G : Stone chip P : Faded S : Rust SC : Rust & Corrosion U : Dent X : Defective Y : Crack, Gap</p>
Remarks (L) Front Seat - Grime - Small / (R) Front Seat - Grime - Medium / Rear Seat - Grime - Large / Trunk Room - Worn, Scratch, Cut, Crack - Medium / (R) Front Floor Mat - Missing - Yes / (L) Front Floor Mat - Missing - Yes / Mat Other - Missing - Yes / Console, Switchs, Vents - Worn, Scratch, Cut, Crack - Small / Dashboard - Worn, Scratch, Cut, Crack - Small / Ceiling - Grime - Small	Remarks Rear Bumper, Lamps, Panels - Scratch - Small / Trunk Hood, Rear Gate - Scratch - Small / Roof - Scratch - Small / (R) Rear Door, Molding - Scratch - Small / (R) Front Door, Molding - Scratch - Small / (R) Rear Fender, Molding - Scratch - Small / (R) Front Fender, Molding - Scratch - Small / Bonnet, Headlight - Scratch - Small / Front Bumper, Grille, Lamps - Scratch - Small / (L) Rear Fender, Molding - Scratch - Small / (L) Rear Door, Molding - Scratch - Small / (L) Front Door, Molding - Scratch - Small / (L) Front Fender, Molding - Scratch - Small
