## General Information

Date & Time: 27, Jan, 2026 07:38

<b>Make</b>	Toyota	<b>Model</b>	Vios
<b>YOM</b>	2025	<b>Odo Meter Reading</b>	1,399
<b>Registration No.</b>	NJC5903	<b>Chassis No.</b>	PA1B18F33S4285993
<b>CC</b>	1.3	<b>Transmission</b>	CVT
<b>Fuel Type</b>	Gas	<b>Type of Body</b>	Sedan
<b>Colour</b>	Red Mica Metallic

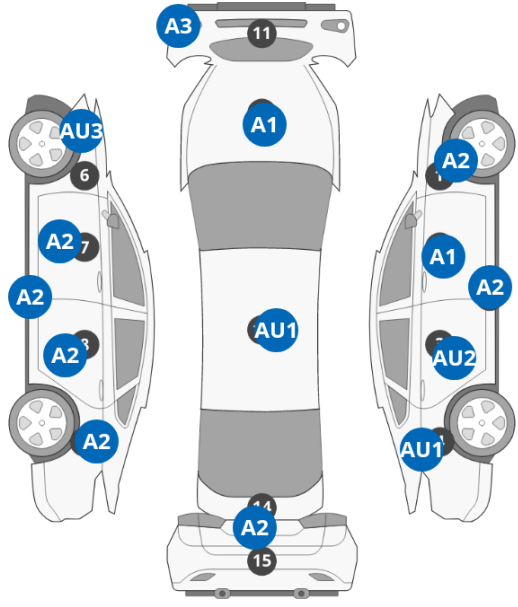
<p><b>A</b> : Scratch <b>AU</b> : Scratch &amp; Dent <b>B</b> : Modified <b>C</b> : Corrosion <b>G</b> : Stone chip <b>P</b> : Faded <b>S</b> : Rust <b>SC</b> : Rust &amp; Corrosion <b>U</b> : Dent <b>X</b> : Defective <b>Y</b> : Crack, Gap</p>
<p><b>Remarks</b> (L) Front Seat - Grime - Minimal / (R) Front Seat - Grime - Minimal / (L) Front Trim - Grime - Minimal / (R) Front Trim - Grime - Minimal / Ceiling - Grime - Minimal / Rear Seat - Grime - Minimal</p>	<p><b>Remarks</b> Roof - Scratch &amp; Dent - Minimal / (L) Front Door, Molding - Scratch - Small / (R) Front Door, Molding - Scratch - Minimal / Bonnet, Headlight - Scratch - Minimal / (L) Front Fender, Molding - Scratch &amp; Dent - Medium / Front Bumper, Grille, Lamps - Scratch - Medium / (L) Rear Door, Molding - Scratch - Small / (L) Rear Fender, Molding - Scratch - Small / Trunk Hood, Rear Gate - Scratch - Small / (R) Rear Fender, Molding - Scratch &amp; Dent - Minimal / (R) Rear Door, Molding - Scratch &amp; Dent - Small / (R) Step, In-panel, Side Spoiler - Scratch - Small / (R) Front Fender, Molding - Scratch - Small / (L) Step, In-panel, Side Spoiler - Scratch - Small</p>
