## General Information

Date & Time: 26, Jan, 2026 18:04

<b>Make</b>	Toyota	<b>Model</b>	Vios
<b>YOM</b>	2025	<b>Odo Meter Reading</b>	27,672
<b>Registration No.</b>	NHU8745	<b>Chassis No.</b>	PA1B18F34R4277444
<b>CC</b>	1.3	<b>Transmission</b>	CVT
<b>Fuel Type</b>	Gas	<b>Type of Body</b>	Sedan
<b>Colour</b>	Red Mica Metallic

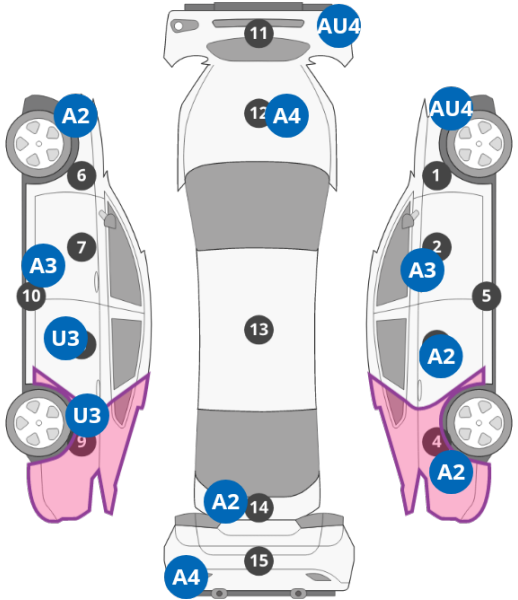
<p><b>A</b> : Scratch <b>AU</b> : Scratch &amp; Dent <b>B</b> : Modified <b>C</b> : Corrosion <b>G</b> : Stone chip <b>P</b> : Faded <b>S</b> : Rust <b>SC</b> : Rust &amp; Corrosion <b>U</b> : Dent <b>X</b> : Defective <b>Y</b> : Crack, Gap</p>
<p><b>Remarks</b> Rear Seat - Grime - Large / (R) Front Floor Mat - Worked - Large / (R) Front Trim - Grime - Small / Dashboard - Traces of Adhesive Tape - Yes / (L) Front Trim - Grime - Small / (L) Front Floor Mat - Worked - Large / (L) Front Seat - Grime - Small</p>	<p><b>Remarks</b> (L) Rear Door, Molding - Dent - Medium / (L) Rear Fender, Molding - Dent - Medium / (L) Front Door, Molding - Scratch - Medium / (L) Front Fender, Molding - Scratch - Small / Bonnet, Headlight - Scratch - Large / Front Bumper, Grille, Lamps - Scratch &amp; Dent - Large / (R) Front Fender, Molding - Scratch &amp; Dent - Large / (R) Front Door, Molding - Scratch - Medium / (R) Rear Door, Molding - Scratch - Small / (R) Rear Fender, Molding - Scratch - Small / Rear Bumper, Lamps, Panels - Scratch - Large / Trunk Hood, Rear Gate - Scratch - Small / (L) Rear Wheel, Cover - Cap Missing - Yes / (R) Rear Wheel, Cover - Cap Missing - Yes</p>
