## General Information

Date & Time: 27, Jan, 2026 15:45

<b>Make</b>	Toyota	<b>Model</b>	Hilux Tamaraw
<b>YOM</b>	2025	<b>Odo Meter Reading</b>	20,623
<b>Registration No.</b>	DBT8510	<b>Chassis No.</b>	PAHACACA7S6421855
<b>CC</b>	2.4	<b>Transmission</b>	M/T
<b>Fuel Type</b>	Diesel	<b>Type of Body</b>	Dropside
<b>Colour</b>	White

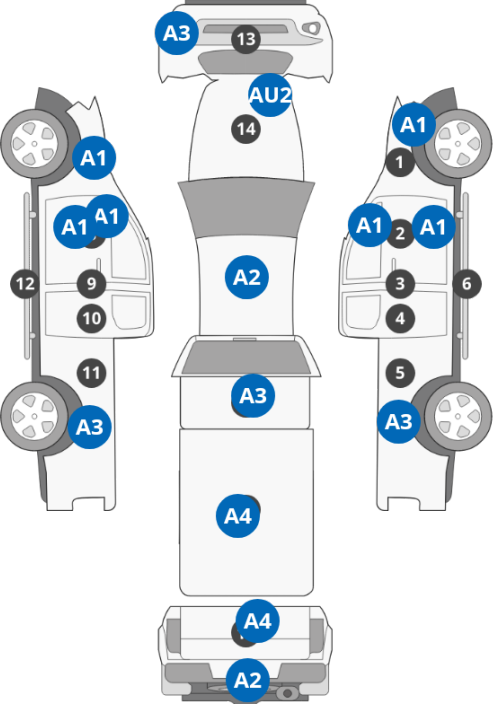
<p><b>A</b> : Scratch <b>AU</b> : Scratch &amp; Dent <b>B</b> : Modified <b>C</b> : Corrosion <b>G</b> : Stone chip <b>P</b> : Faded <b>S</b> : Rust <b>SC</b> : Rust &amp; Corrosion <b>U</b> : Dent <b>X</b> : Defective <b>Y</b> : Crack, Gap</p>
<p><b>Remarks</b> (R) Front Seat - Grime - Large / Ceiling - Grime - Small / Dashboard - Traces of Adhesive Tape - Yes / (L) Front Floor Mat - Grime - Small</p>	<p><b>Remarks</b> Cargo Bed Floor - Scratch - Large / Rear Gate - Scratch - Large / Rear Bumper, Lamps, Panels - Scratch - Small / (L) Guard Frame - Scratch - Medium / (R) Guard Frame - Scratch - Medium / Cab Back Panel - Scratch - Medium / (R) Mirror - Scratch - Minimal / (R) Front Door, Molding - Scratch - Minimal / (R) Front Fender, Molding - Scratch - Minimal / Bonnet, Headlight - Scratch &amp; Dent - Small / Front Bumper, Grille, Lamps - Scratch - Medium / (L) Front Fender, Molding - Scratch - Minimal / (L) Mirror - Scratch - Minimal / (L) Front Door, Molding - Scratch - Minimal / Roof - Scratch - Small</p>
