## General Information

Date & Time: 26, Jan, 2026 16:03

<b>Make</b>	Toyota	<b>Model</b>	Wigo
<b>YOM</b>	2025	<b>Odo Meter Reading</b>	3,666
<b>Registration No.</b>	DBS8839	<b>Chassis No.</b>	MHKAA1BC0RJ034032
<b>CC</b>	1.0	<b>Transmission</b>	CVT
<b>Fuel Type</b>	Gas	<b>Type of Body</b>	Hatchback
<b>Colour</b>	Gray

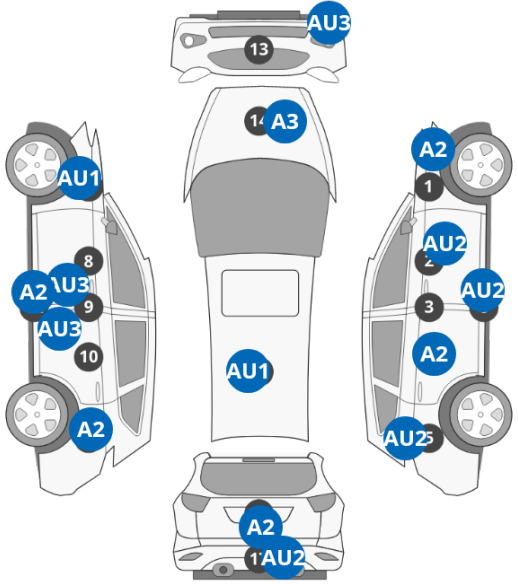
<p><b>A</b> : Scratch <b>AU</b> : Scratch &amp; Dent <b>B</b> : Modified <b>C</b> : Corrosion <b>G</b> : Stone chip <b>P</b> : Faded <b>S</b> : Rust <b>SC</b> : Rust &amp; Corrosion <b>U</b> : Dent <b>X</b> : Defective <b>Y</b> : Crack, Gap</p>
<b>Remarks</b> (L) Front Seat - Grime - Minimal / (R) Front Seat - Grime - Minimal / (L) Front Trim - Grime - Minimal / (R) Front Trim - Grime - Minimal / Rear Seat - Grime - Minimal	<b>Remarks</b> (L) Front Door, Molding - Scratch & Dent - Medium / (L) Rear Door, Molding - Scratch & Dent - Medium / (L) Step, In-panel, Side Spoiler - Scratch - Small / (L) Rear Fender, Molding - Scratch - Small / Trunk Hood, Rear Gate - Scratch - Small / Rear Bumper, Lamps, Panels - Scratch & Dent - Small / (R) Rear Fender, Molding - Scratch & Dent - Small / (R) Rear Door, Molding - Scratch - Small / (R) Step, In-panel, Side Spoiler - Scratch & Dent - Small / (R) Front Door, Molding - Scratch & Dent - Small / Roof - Scratch & Dent - Minimal / (R) Front Fender, Molding - Scratch - Small / Bonnet, Headlight - Scratch - Medium / Front Bumper, Grille, Lamps - Scratch & Dent - Medium / (L) Front Fender, Molding - Scratch & Dent - Minimal
