## General Information

Date & Time: 26, Jan, 2026 10:28

<b>Make</b>	Toyota	<b>Model</b>	Vios
<b>YOM</b>	2024	<b>Odo Meter Reading</b>	34,521
<b>Registration No.</b>	DBO9892	<b>Chassis No.</b>	PA1B18F3XR4259868
<b>CC</b>	1.3	<b>Transmission</b>	CVT
<b>Fuel Type</b>	Gas	<b>Type of Body</b>	Sedan
<b>Colour</b>	Red Mica Metallic

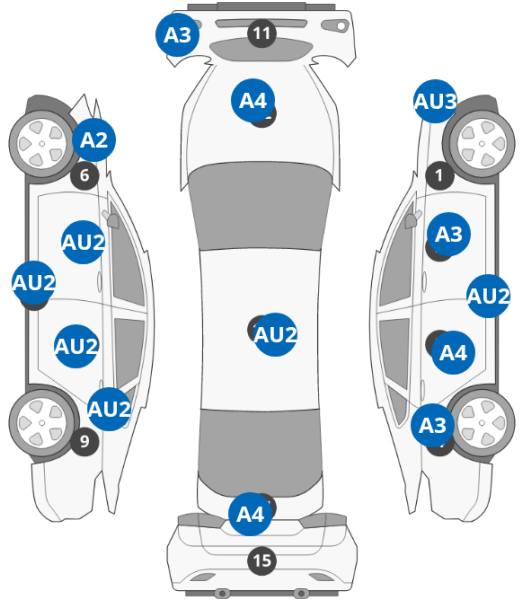
<p><b>A</b> : Scratch <b>AU</b> : Scratch &amp; Dent <b>B</b> : Modified <b>C</b> : Corrosion <b>G</b> : Stone chip <b>P</b> : Faded <b>S</b> : Rust <b>SC</b> : Rust &amp; Corrosion <b>U</b> : Dent <b>X</b> : Defective <b>Y</b> : Crack, Gap</p>
<p><b>Remarks</b> (L) Front Floor Mat - Cut, Crack - Medium / (R) Front Floor Mat - Grime - Small / (L) Front Seat - Grime - Medium / Rear Seat - Grime - Medium / (R) Front Seat - Grime - Small / (L) Front Trim - Grime - Small / (R) Front Trim - Grime - Small / Ceiling - Grime - Small</p>	<p><b>Remarks</b> (R) Front Fender - Repair Traces - Yes / (L) Front Fender - Repair Traces - Yes / Trunk Hood, Rear Gate - Scratch - Large / (L) Rear Fender, Molding - Scratch &amp; Dent - Small / Roof - Scratch &amp; Dent - Small / (L) Rear Door, Molding - Scratch &amp; Dent - Small / (L) Front Door, Molding - Scratch &amp; Dent - Small / (L) Front Fender, Molding - Scratch - Small / Front Bumper, Grille, Lamps - Scratch - Medium / Bonnet, Headlight - Scratch - Large / (R) Front Fender, Molding - Scratch &amp; Dent - Medium / (R) Front Door, Molding - Scratch - Medium / (R) Rear Door, Molding - Scratch - Large / (R) Rear Fender, Molding - Scratch - Medium / (R) Step, In-panel, Side Spoiler - Scratch &amp; Dent - Small / (L) Step, In-panel, Side Spoiler - Scratch &amp; Dent - Small</p>
