## General Information

Date & Time: 26, Jan, 2026 10:03

<b>Make</b>	Toyota	<b>Model</b>	Raize
<b>YOM</b>	2024	<b>Odo Meter Reading</b>	39,775
<b>Registration No.</b>	DBN7185	<b>Chassis No.</b>	MHKAB1BA8PJ069894
<b>CC</b>	1.2	<b>Transmission</b>	CVT
<b>Fuel Type</b>	Gas	<b>Type of Body</b>	SUV
<b>Colour</b>	Gray

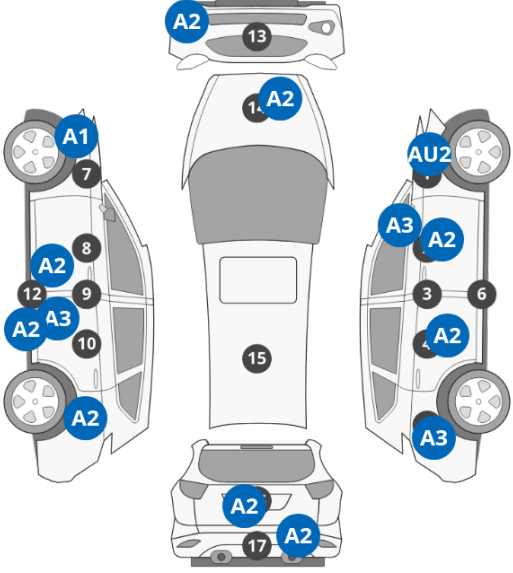
<p><b>A</b> : Scratch <b>AU</b> : Scratch &amp; Dent <b>B</b> : Modified <b>C</b> : Corrosion <b>G</b> : Stone chip <b>P</b> : Faded <b>S</b> : Rust <b>SC</b> : Rust &amp; Corrosion <b>U</b> : Dent <b>X</b> : Defective <b>Y</b> : Crack, Gap</p>
<p><b>Remarks</b> (R) Front Seat - Grime - Medium / (R) Front Trim - Grime - Small / Rear Seat - Grime - Small / Trunk Room - Worn, Scratch, Cut, Crack - Small / (L) Rear Trim - Grime - Minimal / (L) Front Trim - Grime - Minimal / (L) Front Seat - Grime - Small / Console, Switches, Vents - Worn, Scratch, Cut, Crack - Medium / Ceiling - Grime - Small / Dashboard - Worn, Scratch, Cut, Crack - Minimal</p>	<p><b>Remarks</b> (L) Front Fender, Molding - Scratch - Minimal / (L) Front Door, Molding - Scratch - Small / (L) Rear Door, Molding - Scratch - Medium / (L) Rear Fender, Molding - Scratch - Small / (L) Step, In-panel, Side Spoiler - Scratch - Small / Trunk Hood, Rear Gate - Scratch - Small / Rear Bumper, Lamps, Panels - Scratch - Small / (R) Rear Fender, Molding - Scratch - Medium / (R) Rear Door, Molding - Scratch - Small / (R) Front Door, Molding - Scratch - Small / (R) Mirror - Scratch - Medium / (R) Front Fender, Molding - Scratch &amp; Dent - Small / Bonnet, Headlight - Scratch - Small / Front Bumper, Grille, Lamps - Scratch - Small</p>
