## General Information

Date & Time: 26, Jan, 2026 12:38

<b>Make</b>	Toyota	<b>Model</b>	Vios
<b>YOM</b>	2024	<b>Odo Meter Reading</b>	80,134
<b>Registration No.</b>	CCA3806	<b>Chassis No.</b>	PA1B18F36P4229215
<b>CC</b>	1.3	<b>Transmission</b>	CVT
<b>Fuel Type</b>	Gas	<b>Type of Body</b>	Sedan
<b>Colour</b>	Green

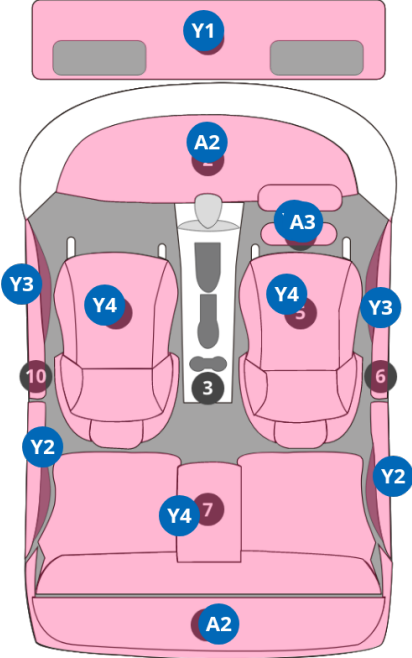
<b>Interior Evaluation :</b> <span style="float: right; color: red; font-weight: bold;">E</span>	<b>Exterior Evaluation :</b> <span style="float: right; color: red; font-weight: bold;">E</span>

<p><b>A</b> : Scratch <b>AU</b> : Scratch &amp; Dent <b>B</b> : Modified <b>C</b> : Corrosion <b>G</b> : Stone chip <b>P</b> : Faded <b>S</b> : Rust <b>SC</b> : Rust &amp; Corrosion <b>U</b> : Dent <b>X</b> : Defective <b>Y</b> : Crack, Gap</p>
<p><b>Remarks</b> (R) Front Seat - Grime - Large / (R) Front Floor Mat - Grime - Medium / (R) Front Trim - Grime - Medium / Rear Seat - Grime - Large / (R) Rear Trim - Grime - Small / (L) Rear Trim - Grime - Small / (L) Front Trim - Grime - Medium / (L) Front Floor Mat - Cut, Crack - Medium / (L) Front Seat - Grime - Large / Ceiling - Grime - Minimal / Dashboard - Worn, Scratch, Cut, Crack - Small / Trunk Room - Worn, Scratch, Cut, Crack - Small</p>	<p><b>Remarks</b> Trunk Hood, Rear Gate - Repair Traces - Yes / Front Bumper, Grille, Lamps - Scratch &amp; Dent - Large / (L) Front Fender, Molding - Scratch &amp; Dent - Medium / (L) Mirror - Scratch - Minimal / Bonnet, Headlight - Scratch - Small / (R) Front Fender, Molding - Scratch &amp; Dent - Small / (R) Front Door, Molding - Scratch &amp; Dent - Large / (R) Step, In-panel, Side Spoiler - Scratch &amp; Dent - Medium / (R) Rear Door, Molding - Scratch &amp; Dent - Large / (R) Rear Fender, Molding - Scratch - Medium / Trunk Hood, Rear Gate - Scratch &amp; Dent - Medium / Rear Bumper, Lamps, Panels - Scratch &amp; Dent - Large / (L) Rear Fender, Molding - Scratch - Small / (L) Rear Door, Molding - Scratch - Small / (L) Front Door, Molding - Scratch - Medium / Roof - Scratch &amp; Dent - Small</p>
