General Information

Date & Time: 22, Jan, 2026 15:15

Make	Toyota	Model	Vios
YOM	2022	Odo Meter Reading	102,978
Registration No.	NGX1629	Chassis No.	PA1B18F33N4171545
CC	1.3	Transmission	CVT
Fuel Type	Gas	Type of Body	Sedan
Colour	Black

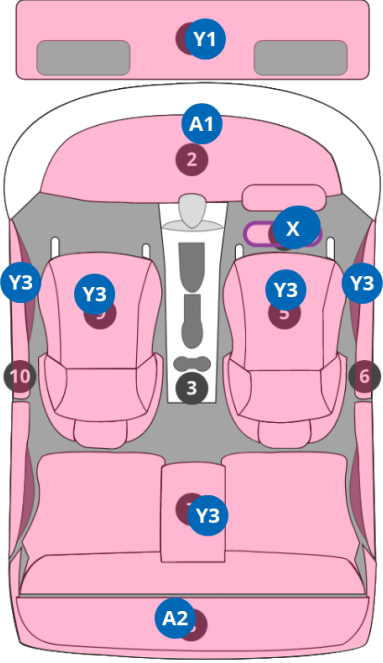
<p>a : Cut, Fray d : Loose, Deformed k : Animal Hair s : Smell t : Cigarette Burns x : Defective y : Stain</p>

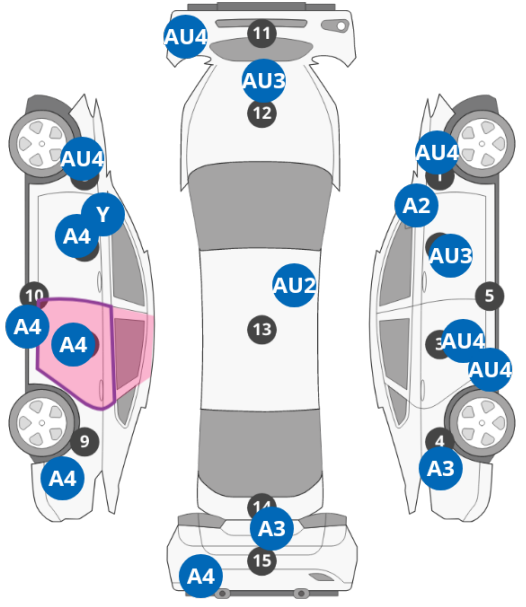
<p>A : Scratch AU : Scratch & Dent B : Modified C : Corrosion G : Stone chip P : Faded S : Rust SC : Rust & Corrosion U : Dent X : Defective Y : Crack, Gap</p>
Remarks (R) Front Seat - Grime - Medium / (R) Front Floor Mat - Missing - Yes / (L) Front Floor Mat - Missing - Yes / Mat Other - Missing - Yes / (R) Front Trim - Grime - Medium / Rear Seat - Grime - Medium / Trunk Room - Worn, Scratch, Cut, Crack - Small / (L) Front Trim - Grime - Medium / (L) Front Seat - Grime - Medium / Dashboard - Worn, Scratch, Cut, Crack - Minimal / Room Mirror - Missing - Yes / Ceiling - Grime - Minimal	Remarks (R) Front Fender - Repair Traces - Yes / Bonnet - Repair Traces - Yes / (L) Front Fender - Repair Traces - Yes / (L) Front Door - Repair Traces - Yes / (L) Rear Door - Repair Traces - Yes / (L) Rear Door, Molding - Repair mark - Yes / Rear Bumper, Lamps, Panels - Scratch - Large / Trunk Hood, Rear Gate - Scratch - Medium / (L) Rear Fender, Molding - Scratch - Large / (L) Rear Door, Molding - Scratch - Large / (L) Step, In-panel, Side Spoiler - Scratch - Large / (L) Front Door, Molding - Scratch - Large / (L) Mirror - Crack - Damaged / (L) Front Fender, Molding - Scratch & Dent - Large / Front Bumper, Grille, Lamps - Scratch & Dent - Large / Bonnet, Headlight - Scratch & Dent - Medium / (R) Mirror - Scratch - Small / (R) Front Door, Molding - Scratch & Dent - Medium / (R) Rear Door, Molding - Scratch & Dent - Large / (R) Step, In-panel, Side Spoiler - Scratch & Dent - Large / (R) Rear Fender, Molding - Scratch - Medium / Roof - Scratch & Dent - Small / (R) Front Fender, Molding - Scratch & Dent - Large
