General Information

Date & Time: 23, Jan, 2026 11:34

Make	Hyundai	Model	Accent
YOM	2018	Odo Meter Reading	91,675
Registration No.	NCM5113	Chassis No.	KMHCT41BHU334476
CC	1.4	Transmission	A/T
Fuel Type	Gas	Type of Body	Sedan
Colour	Red

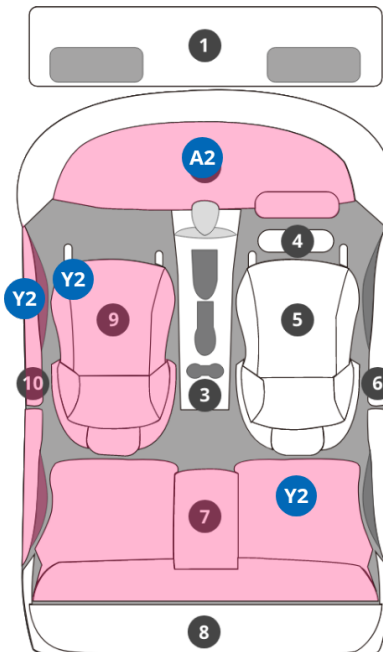
Interior Evaluation : A	Exterior Evaluation : C

<p>a : Cut, Fray d : Loose, Deformed k : Animal Hair s : Smell t : Cigarette Burns x : Defective y : Stain</p>

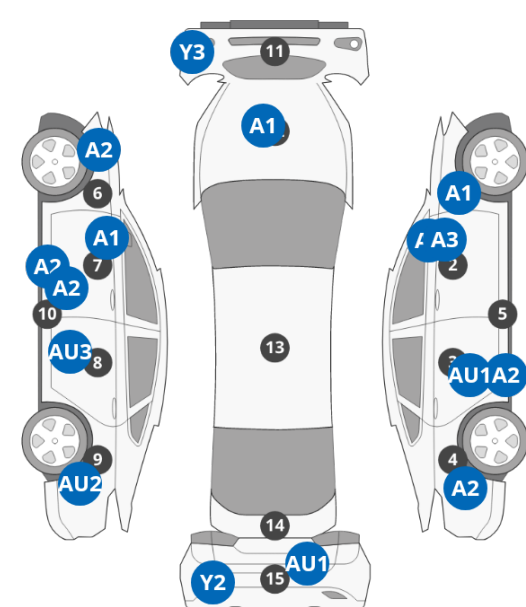
<p>A : Scratch AU : Scratch & Dent B : Modified C : Corrosion G : Stone chip P : Faded S : Rust SC : Rust & Corrosion U : Dent X : Defective Y : Crack, Gap</p>
<p>Remarks Steering Wheel - Worn, Peel, Crack - Small / Rear Seat - Grime - Small / (L) Front Seat - Grime - Small / (L) Front Trim - Grime - Small</p>	<p>Remarks (L) Front Fender - Repair Traces - Yes / (L) Front Door - Repair Traces - Yes / (L) Rear Fender - Repair Traces - Yes / (R) Rear Door - Repair Traces - Yes / Roof - Repair Traces - Yes / (R) Front Fender, Molding - Scratch - Minimal / (R) Mirror - Scratch - Minimal / (R) Front Door, Molding - Scratch - Medium / (R) Step, In-panel, Side Spoiler - Scratch - Small / (R) Rear Door, Molding - Scratch & Dent - Minimal / Overall Exterior - Full Re-Paint in same color - Yes / (R) Rear Fender, Molding - Scratch - Small / Rear Bumper, Lamps, Panels - Crack, Gap - Small / Trunk Hood, Rear Gate - Scratch & Dent - Minimal / (L) Rear Fender, Molding - Scratch & Dent - Small / (L) Rear Door, Molding - Scratch & Dent - Medium / (L) Step, In-panel, Side Spoiler - Scratch - Small / (L) Front Door, Molding - Scratch - Small / (L) Mirror - Scratch - Minimal / (L) Front Fender, Molding - Scratch - Small / Front Bumper, Grille, Lamps - Crack, Gap - Medium / Bonnet, Headlight - Scratch - Minimal</p>
