## General Information

<b>Make</b>	Mitsubishi	<b>Model</b>	Xpander
<b>YOM</b>	2019	<b>Odo Meter Reading</b>	75,782
<b>Registration No.</b>	NFT2993	<b>Chassis No.</b>	MK2XRNC1WKN042930
<b>CC</b>	1.5	<b>Transmission</b>	A/T
<b>Fuel Type</b>	Gas	<b>Type of Body</b>	MPV
<b>Colour</b>	Gray

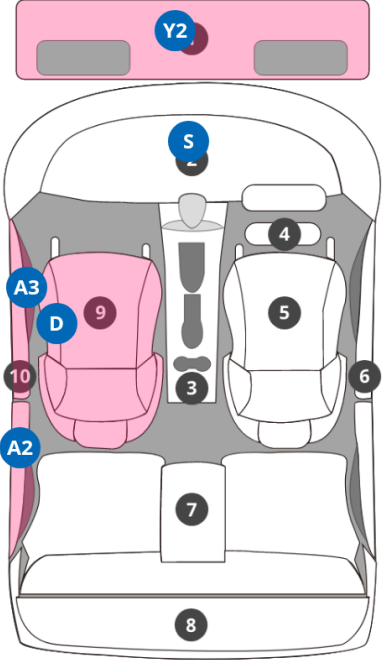
<b>Interior Evaluation :</b> <span style="float: right; color: red; font-weight: bold;">C</span>	<b>Exterior Evaluation :</b> <span style="float: right; color: red; font-weight: bold;">E</span>

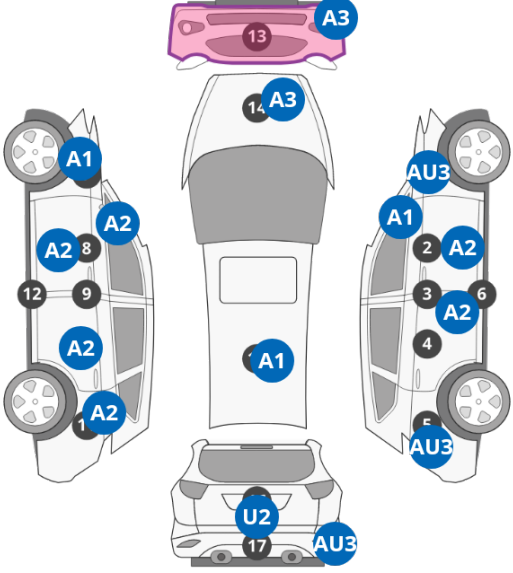
<p><b>A</b> : Scratch <b>AU</b> : Scratch &amp; Dent <b>B</b> : Modified <b>C</b> : Corrosion <b>G</b> : Stone chip <b>P</b> : Faded <b>S</b> : Rust <b>SC</b> : Rust &amp; Corrosion <b>U</b> : Dent <b>X</b> : Defective <b>Y</b> : Crack, Gap</p>
<p><b>Remarks</b> Overall Interior - Worn as per age - Yes / (L) Front Trim - Cut, Crack - Medium / (L) Rear Trim - Cut, Crack - Small / (L) Front Seat - Worn - Yes / Ceiling - Grime - Small / Overall Interior - Smell - Yes</p>	<p><b>Remarks</b> (L) Front Door - Repair Traces - Yes / (L) Rear Door - Repair Traces - Yes / Trunk Hood, Rear Gate - Repair Traces - Yes / (R) Mirror - Scratch - Minimal / (R) Front Fender, Molding - Scratch &amp; Dent - Medium / (R) Rear Door, Molding - Scratch - Small / (R) Front Door, Molding - Scratch - Small / (R) Rear Fender, Molding - Scratch &amp; Dent - Medium / Rear Bumper, Lamps, Panels - Scratch &amp; Dent - Medium / Trunk Hood, Rear Gate - Dent - Small / (L) Rear Fender, Molding - Scratch - Small / (L) Rear Door, Molding - Scratch - Small / (L) Front Door, Molding - Scratch - Small / (L) Mirror - Scratch - Small / (L) Front Fender, Molding - Scratch - Minimal / Front Bumper, Grille, Lamps - Repair mark - Yes / Front Bumper, Grille, Lamps - Scratch - Medium / Bonnet, Headlight - Scratch - Medium / Roof - Scratch - Minimal</p>
