## General Information

Date & Time: 26, Jan, 2026 15:57

<b>Make</b>	Mitsubishi	<b>Model</b>	Mirage
<b>YOM</b>	2023	<b>Odo Meter Reading</b>	40,523
<b>Registration No.</b>	EAF4979	<b>Chassis No.</b>	PAEA13TJPNA002964
<b>CC</b>	1.2	<b>Transmission</b>	A/T
<b>Fuel Type</b>	Gas	<b>Type of Body</b>	Sedan
<b>Colour</b>	Red

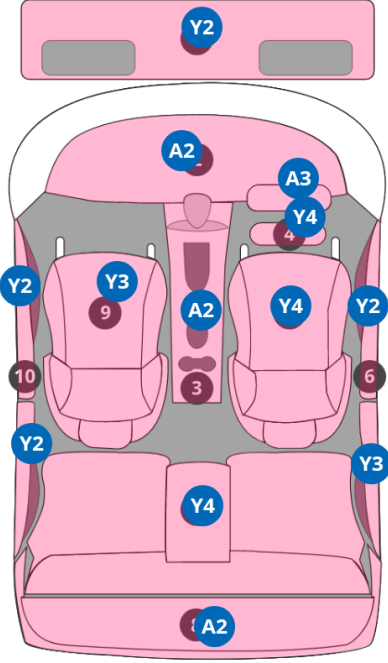
<p><b>a</b> : Cut, Fray <b>d</b> : Loose, Deformed <b>k</b> : Animal Hair <b>s</b> : Smell <b>t</b> : Cigarette Burns <b>x</b> : Defective <b>y</b> : Stain</p>

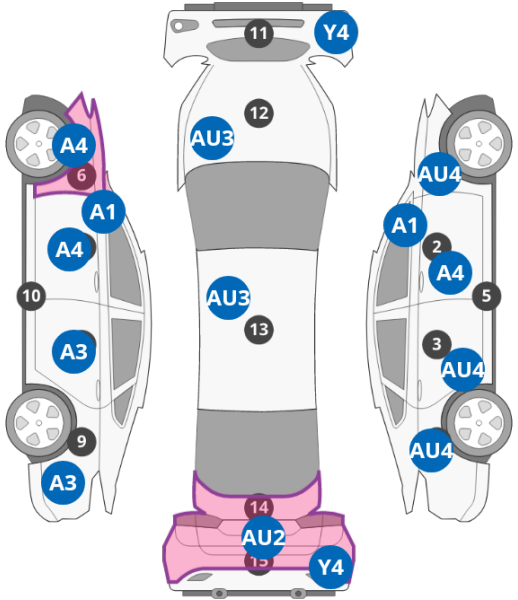
<p><b>A</b> : Scratch <b>AU</b> : Scratch &amp; Dent <b>B</b> : Modified <b>C</b> : Corrosion <b>G</b> : Stone chip <b>P</b> : Faded <b>S</b> : Rust <b>SC</b> : Rust &amp; Corrosion <b>U</b> : Dent <b>X</b> : Defective <b>Y</b> : Crack, Gap</p>
<p><b>Remarks</b> (R) Front Seat - Grime - Large / (R) Front Trim - Grime - Small / Rear Seat - Grime - Large / (R) Rear Trim - Grime - Medium / Trunk Room - Worn, Scratch, Cut, Crack - Small / (L) Rear Trim - Grime - Small / (L) Front Trim - Grime - Small / (L) Front Seat - Grime - Medium / (L) Front Floor Mat - Grime - Large / Steering Wheel - Worn, Peel, Crack - Medium / Ceiling - Grime - Small / Dashboard - Worn, Scratch, Cut, Crack - Small / Console, Switchs, Vents - Worn, Scratch, Cut, Crack - Small</p>	<p><b>Remarks</b> (L) Front Fender - Repair Traces - Yes / Trunk Hood, Rear Gate - Repair Traces - Yes / (L) Mirror - Scratch - Minimal / (L) Front Fender, Molding - Scratch - Large / Bonnet, Headlight - Scratch &amp; Dent - Medium / Front Bumper, Grille, Lamps - Crack, Gap - Large / (R) Front Fender, Molding - Scratch &amp; Dent - Large / (R) Mirror - Scratch - Minimal / (R) Front Door, Molding - Scratch - Large / (R) Rear Door, Molding - Scratch &amp; Dent - Large / (R) Rear Fender, Molding - Scratch &amp; Dent - Large / Rear Bumper, Lamps, Panels - Crack, Gap - Large / Trunk Hood, Rear Gate - Scratch &amp; Dent - Small / (L) Rear Fender, Molding - Scratch - Medium / (L) Rear Door, Molding - Scratch - Medium / (L) Front Door, Molding - Scratch - Large / Roof - Scratch &amp; Dent - Medium / (L) Front Fender, Molding - Repair mark - Yes / Trunk Hood, Rear Gate - Repair mark - Yes</p>
