## General Information

<b>Make</b>	Toyota	<b>Model</b>	Vios
<b>YOM</b>	2022	<b>Odo Meter Reading</b>	41,875
<b>Registration No.</b>	DAS5526	<b>Chassis No.</b>	PA1B18F35N4190534
<b>CC</b>	1.3	<b>Transmission</b>	CVT
<b>Fuel Type</b>	Gas	<b>Type of Body</b>	Sedan
<b>Colour</b>	Blue

## Body / Panel Condition

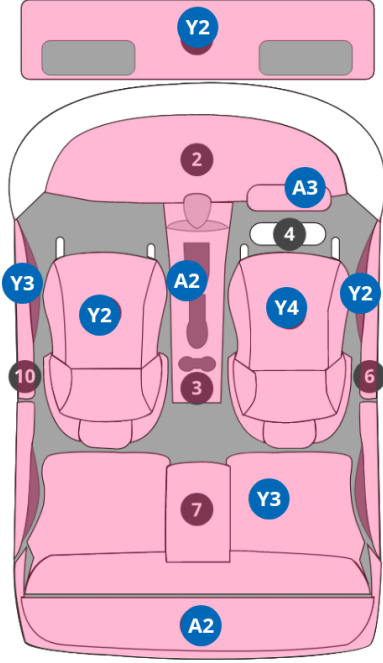
<b>Interior Evaluation :</b> <span style="float: right; color: red; font-weight: bold;">C</span>	<b>Exterior Evaluation :</b> <span style="float: right; color: red; font-weight: bold;">E</span>

<p><b>A</b> : Scratch <b>AU</b> : Scratch &amp; Dent <b>B</b> : Modified <b>C</b> : Corrosion <b>G</b> : Stone chip <b>P</b> : Faded <b>S</b> : Rust <b>SC</b> : Rust &amp; Corrosion <b>U</b> : Dent <b>X</b> : Defective <b>Y</b> : Crack, Gap</p>
<p><b>Remarks</b> (R) Front Seat - Grime - Large / (R) Front Trim - Grime - Small / Rear Seat - Grime - Medium / Trunk Room - Worn, Scratch, Cut, Crack - Small / (L) Front Trim - Grime - Medium / (L) Front Seat - Grime - Small / Steering Wheel - Worn, Peel, Crack - Medium / Ceiling - Grime - Small / Console, Switchs, Vents - Worn, Scratch, Cut, Crack - Small</p>	<p><b>Remarks</b> (R) Front Door - Repair Traces - Yes / (R) Front Fender - Repair Traces - Yes / Bonnet - Repair Traces - Yes / (L) Front Fender - Repair Traces - Yes / (L) Rear Fender - Repair Traces - Yes / Trunk Hood, Rear Gate - Repair Traces - Yes / (R) Rear Fender - Repair Traces - Yes / (R) Rear Door - Repair Traces - Yes / Roof - Repair Traces - Yes / (L) Front Fender, Molding - Scratch - Small / (L) Front Door, Molding - Scratch - Medium / (L) Rear Door, Molding - Scratch - Medium / (L) Rear Fender, Molding - Repair mark - Yes / (L) Rear Fender, Molding - Scratch - Small / Trunk Hood, Rear Gate - Scratch - Medium / Rear Bumper, Lamps, Panels - Scratch - Medium / (R) Rear Fender, Molding - Scratch &amp; Dent - Medium / (R) Rear Door, Molding - Scratch - Large / (R) Front Door, Molding - Scratch &amp; Dent - Medium / (R) Mirror - Scratch - Small / (R) Front Fender, Molding - Scratch - Small / Bonnet, Headlight - Scratch - Medium / Front Bumper, Grille, Lamps - Crack, Gap - Medium / Roof - Scratch - Small</p>
