## General Information

Date & Time: 26, Jan, 2026 11:01

<b>Make</b>	Suzuki	<b>Model</b>	Swift
<b>YOM</b>	2024	<b>Odo Meter Reading</b>	8,347
<b>Registration No.</b>	NHF4000	<b>Chassis No.</b>	MMSZC63S8RR100154
<b>CC</b>	1.2	<b>Transmission</b>	CVT
<b>Fuel Type</b>	Gas	<b>Type of Body</b>	Hatchback
<b>Colour</b>	Red

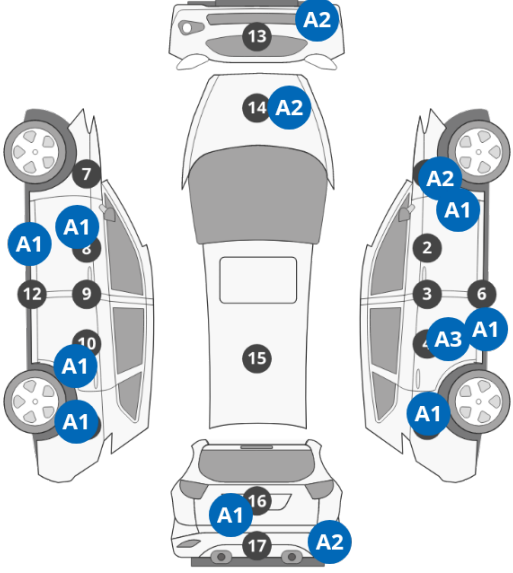
<p><b>A</b> : Scratch <b>AU</b> : Scratch &amp; Dent <b>B</b> : Modified <b>C</b> : Corrosion <b>G</b> : Stone chip <b>P</b> : Faded <b>S</b> : Rust <b>SC</b> : Rust &amp; Corrosion <b>U</b> : Dent <b>X</b> : Defective <b>Y</b> : Crack, Gap</p>
<b>Remarks</b> Defects not found	<b>Remarks</b> (R) Front Fender, Molding - Scratch - Small / (R) Front Door, Molding - Scratch - Minimal / (R) Step, In-panel, Side Spoiler - Scratch - Minimal / (R) Rear Door, Molding - Scratch - Medium / (R) Rear Fender, Molding - Scratch - Minimal / Rear Bumper, Lamps, Panels - Scratch - Small / Trunk Hood, Rear Gate - Scratch - Minimal / (L) Rear Fender, Molding - Scratch - Minimal / (L) Rear Door, Molding - Scratch - Minimal / (L) Step, In-panel, Side Spoiler - Scratch - Minimal / (L) Front Door, Molding - Scratch - Minimal / Bonnet, Headlight - Scratch - Small / Front Bumper, Grille, Lamps - Scratch - Small
